CONTROL OF GAS OUTBURSTS AT MOUNT DAVY MINE

Russell Packham
Ventilation Engineer
Solid Energy NZ Ltd
Huntly
New Zealand.

ABSTRACT

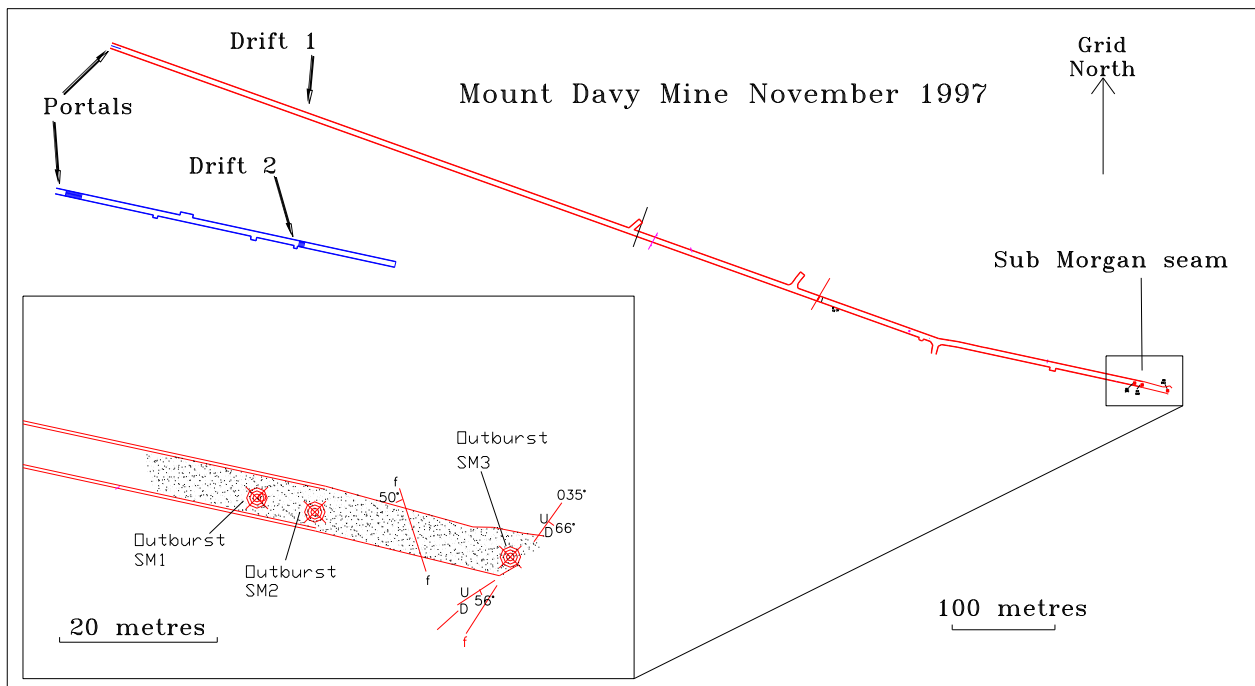
on the 8th October 1997. Figure 1 indicates the location of the first three incidents.

Figure 1. Plan of Mount Davy Mine at 4th November 1997, showing location of outbursts 1 to 3.

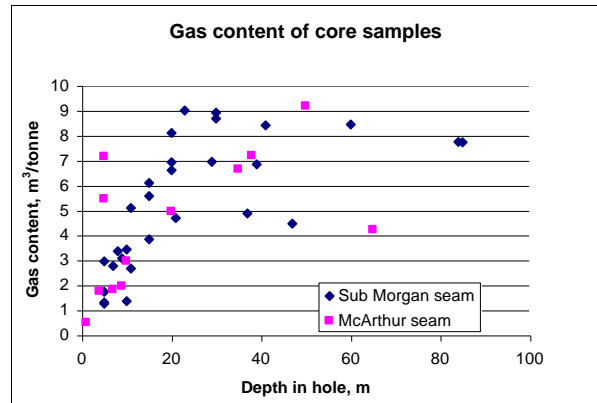
In total 39 gas content tests were conducted indicating a maximum of 9.16 m³/tonne. The distribution of gas contents is shown in Figure 2. A typical gas chromatographic analysis of the seam gas indicated in Table 1.

Figure 3. Gas content of core samples

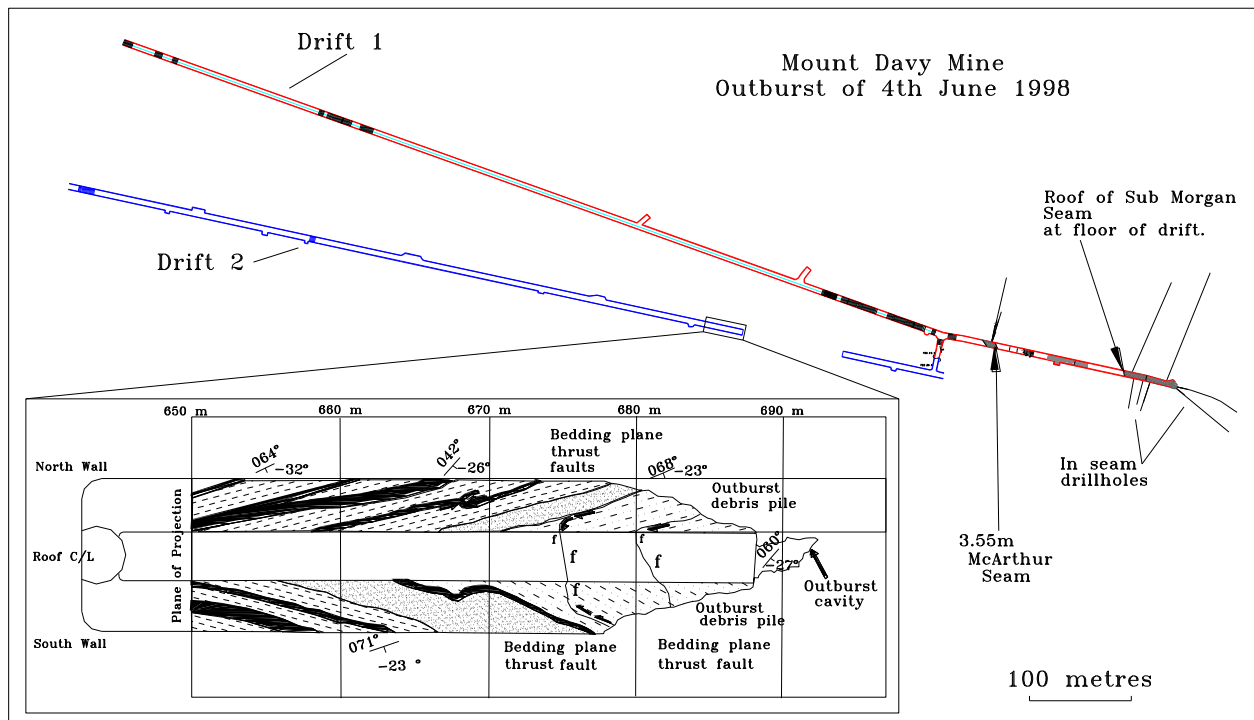
Figure 2. Site of Outburst 5 in Drift2, showing geological structure at outburst site.

At 1604 hrs on 04.06.98, an outburst of coal and gas occurred at 687 m in the face of Drift 2. Approximately 30 tonnes of fine coal was ejected from a 0.8 m seam in the upper left-hand side of the face onto the heading machine. Two operators of the machine were asphyxiated by the methane and buried by the coal towards the rear and to one side of the machine. The quantity of gas emitted by the outburst was estimated as 1529 m³ in the first 30 minutes. Records from a data-logging instrument at the face show that oxygen fell to 5% at the beginning of the outburst. Examination of the coal seam indicated it to be intensely sheared, having an ash content of 55%, and a vitrinite reflectance of 0.92.

Precautionary measures. Following the fatal outburst, the roadheader was removed and only shot firing was permitted for the development of all drives at Mount Davy until a preventative system could be established. The method of shot hole drilling was considered with respect to the likelihood of initiating an outburst. No reference could be found in mining literature to outbursts being induced by drilling of shot holes. Drilling was conducted using a twin boom flameproof drill jumbo with a compressed air supply to the operators cab.

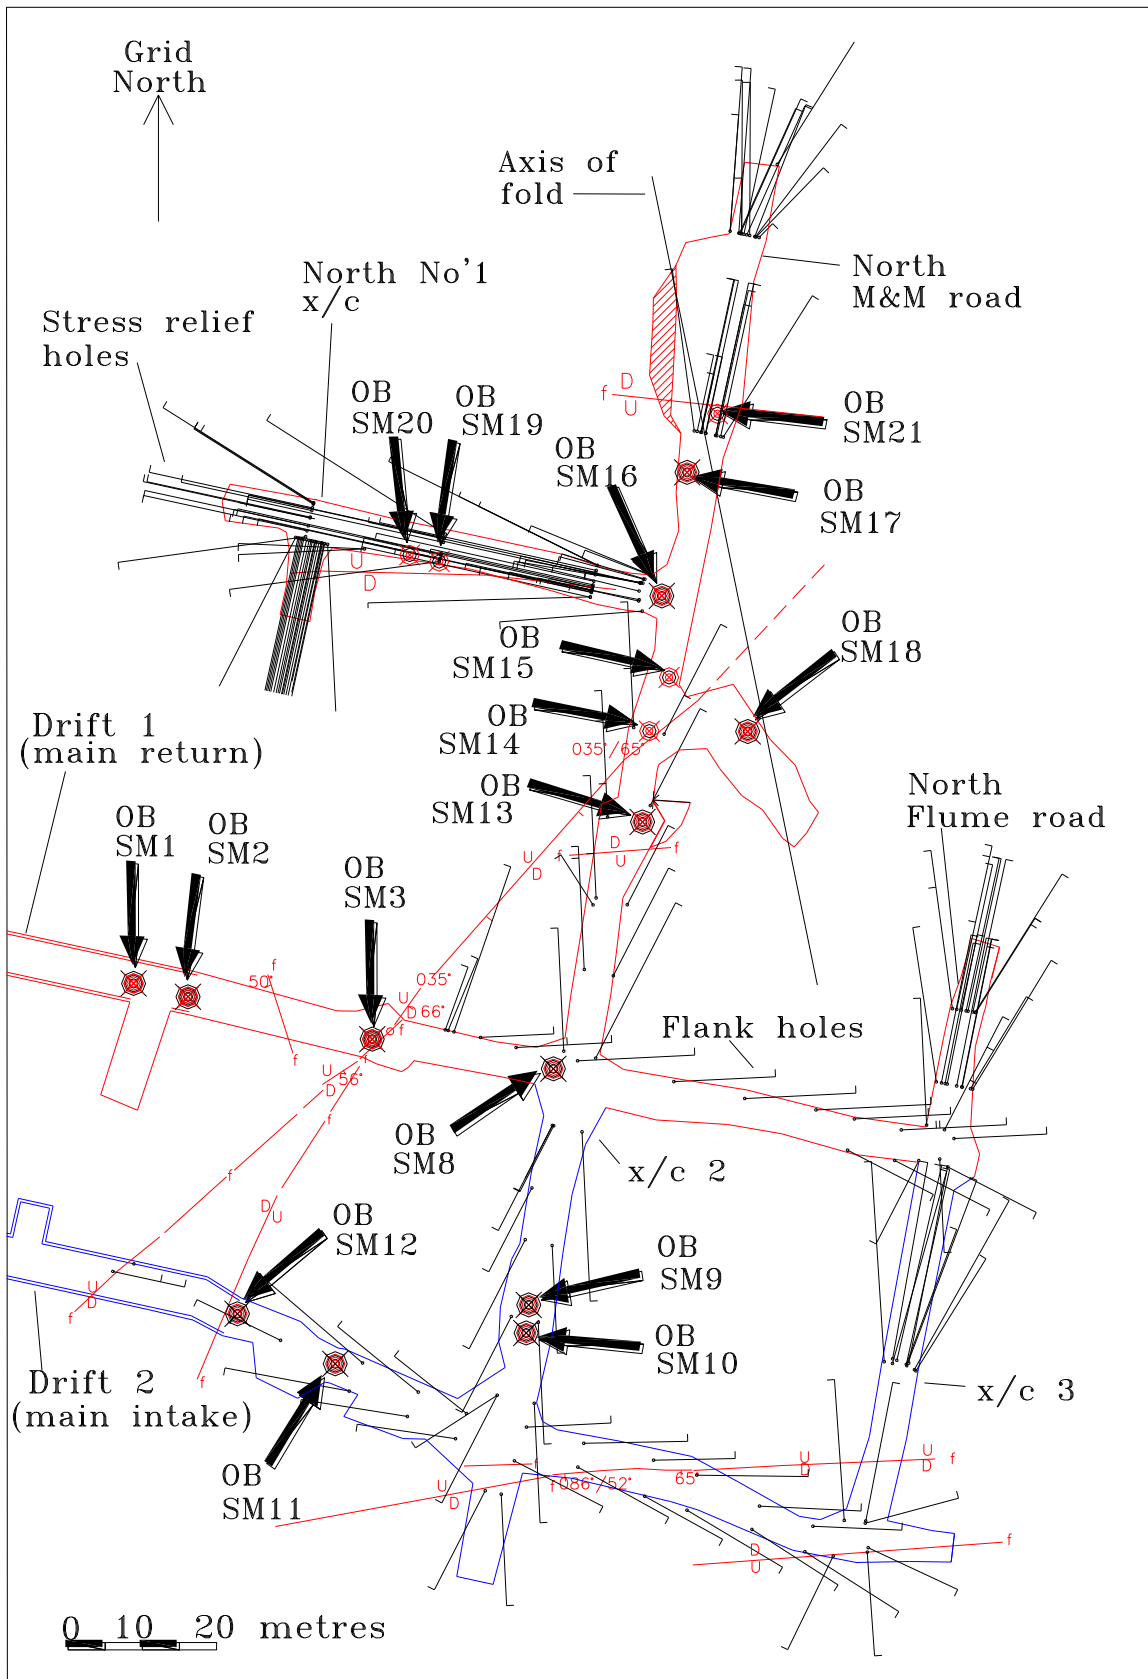
Figure 4. X/C 2 and North M&M drivage outbursts, showing stress relief holes.

Subsequent outbursts in the sub Morgan seam occurred in two locations, in cross cut two drivage connecting the two drifts and in the North M&M drivage. Development in the sub Morgan seam recommenced in December 1998 with the intention of establishing a circuit to Drift 2. The locations of the outbursts are shown in figure 4.

Stress relief drilling. Following consultation with GeoGAS, and in conjunction with DMT a system of stress relief drilling was implemented as an outburst preventative measure. A pattern of eight holes, 25 metres long and 95 mm diameter was implemented for stress relief in the immediate face. Monitoring of cutting volume and gas liberation was systematically recorded to indicate potential outburst zones. A system of dry drilling using 87 mm diameter scroll rods and a 95 mm tri-cone bit was developed to overcome the problem of seizing of rods caused by gas pressure and flushing fluid. Development restarted on 8 June 1999. A “real-time” methane monitoring system was commissioned on 24 June providing readings every 60 seconds.

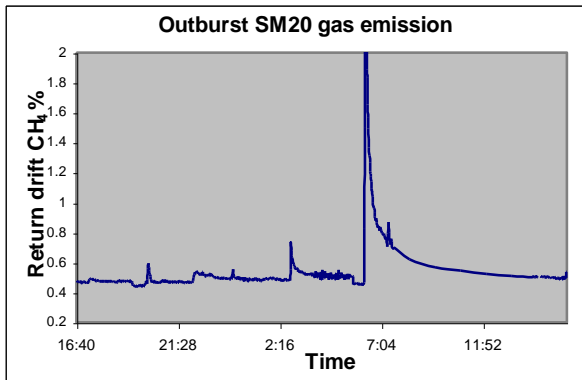
Prior to the outburst incident “SM20” the emission from the previous round released 109 m³ of CH₄. The monitored gas levels in the main return resulting from this emission and that of the outburst “SM20” are shown in figure 5. Calculated gas emissions subsequent to shotfiring are shown in table 4.

Figure 5. Outburst SM20 gas emission.

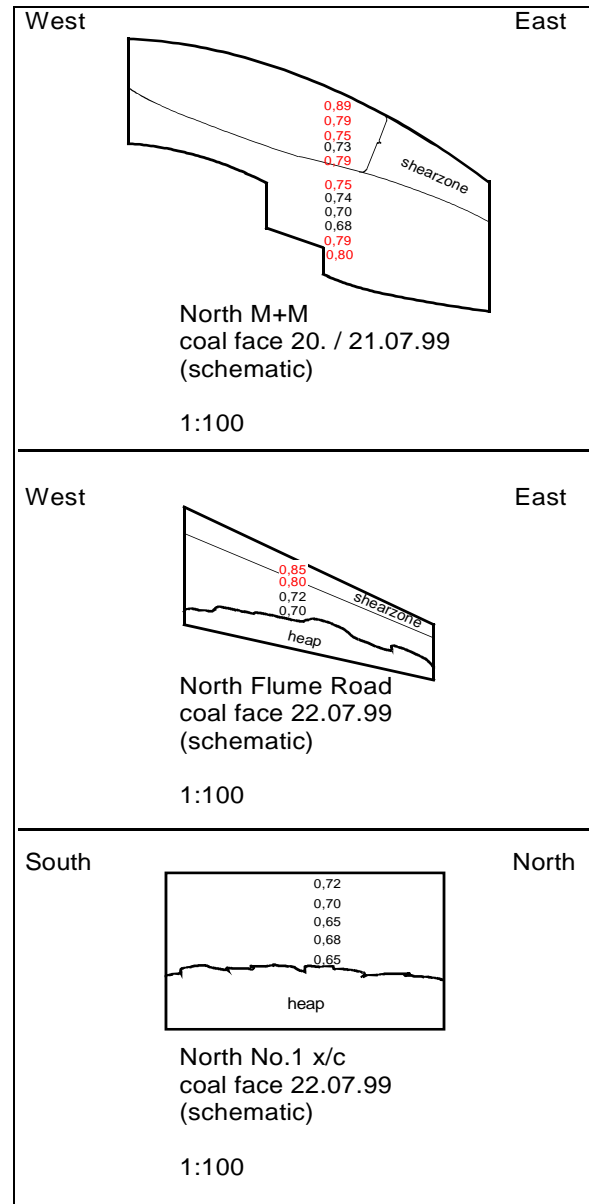
Figure 6 shows the schematic distribution of k_t values derived from the samples taken at three faces in Sub Morgan seam. High k_t -values were identified in the bedding shear zones, immediately beneath the roof of the seam at the face of North M+M and North Flume roads. The bedding shear zones were noticeably thicker in the bend from flat to inclined bedding, specifically in the North M+M road. The coal immediately below the shear zone was also tectonically stressed, but did not display the properties of coal prone to gas outbursts.

Figure 6. k_t desorption characteristics in Sub Morgan seam faces.

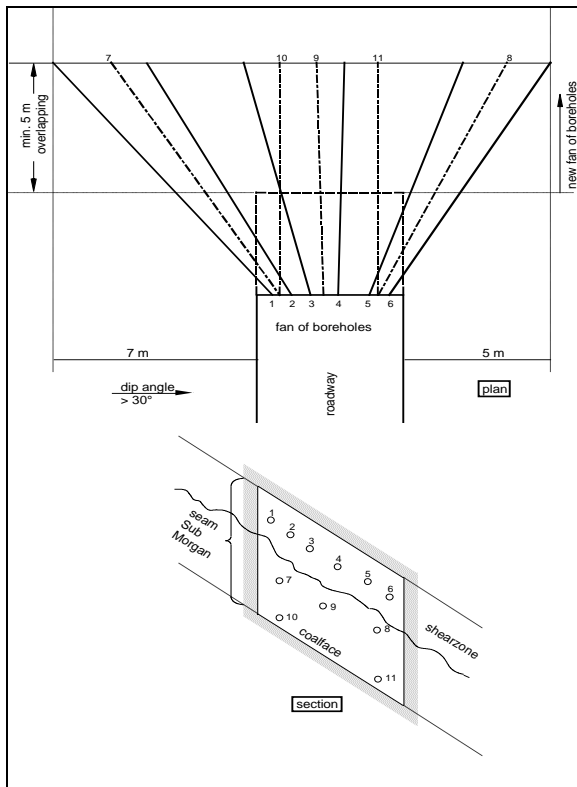
Figure 7. Modification to stress relief borehole pattern, Sub Morgan seam.

- Altering the drilling pattern to focus in the bedding shear zones (see figure 7.)
- Increasing the diameter of relief holes to 140 mm.
- Preparation of a horizontal “slot” in the face across the base of the drivage.

Trials with 140mm diameter relief holes and horizontal slot installation were conducted with apparent improvement in relaxation of the face. The trials were not conducted in locations of extensive bedding shear and remain inconclusive in relation to the ability to prevent outbursts.
