ACARP Project C4033

Stimulation of Gas Make
from Horizontal In-Seam Drain Holes
by Hydraulic Fracturing

Completed December 1999

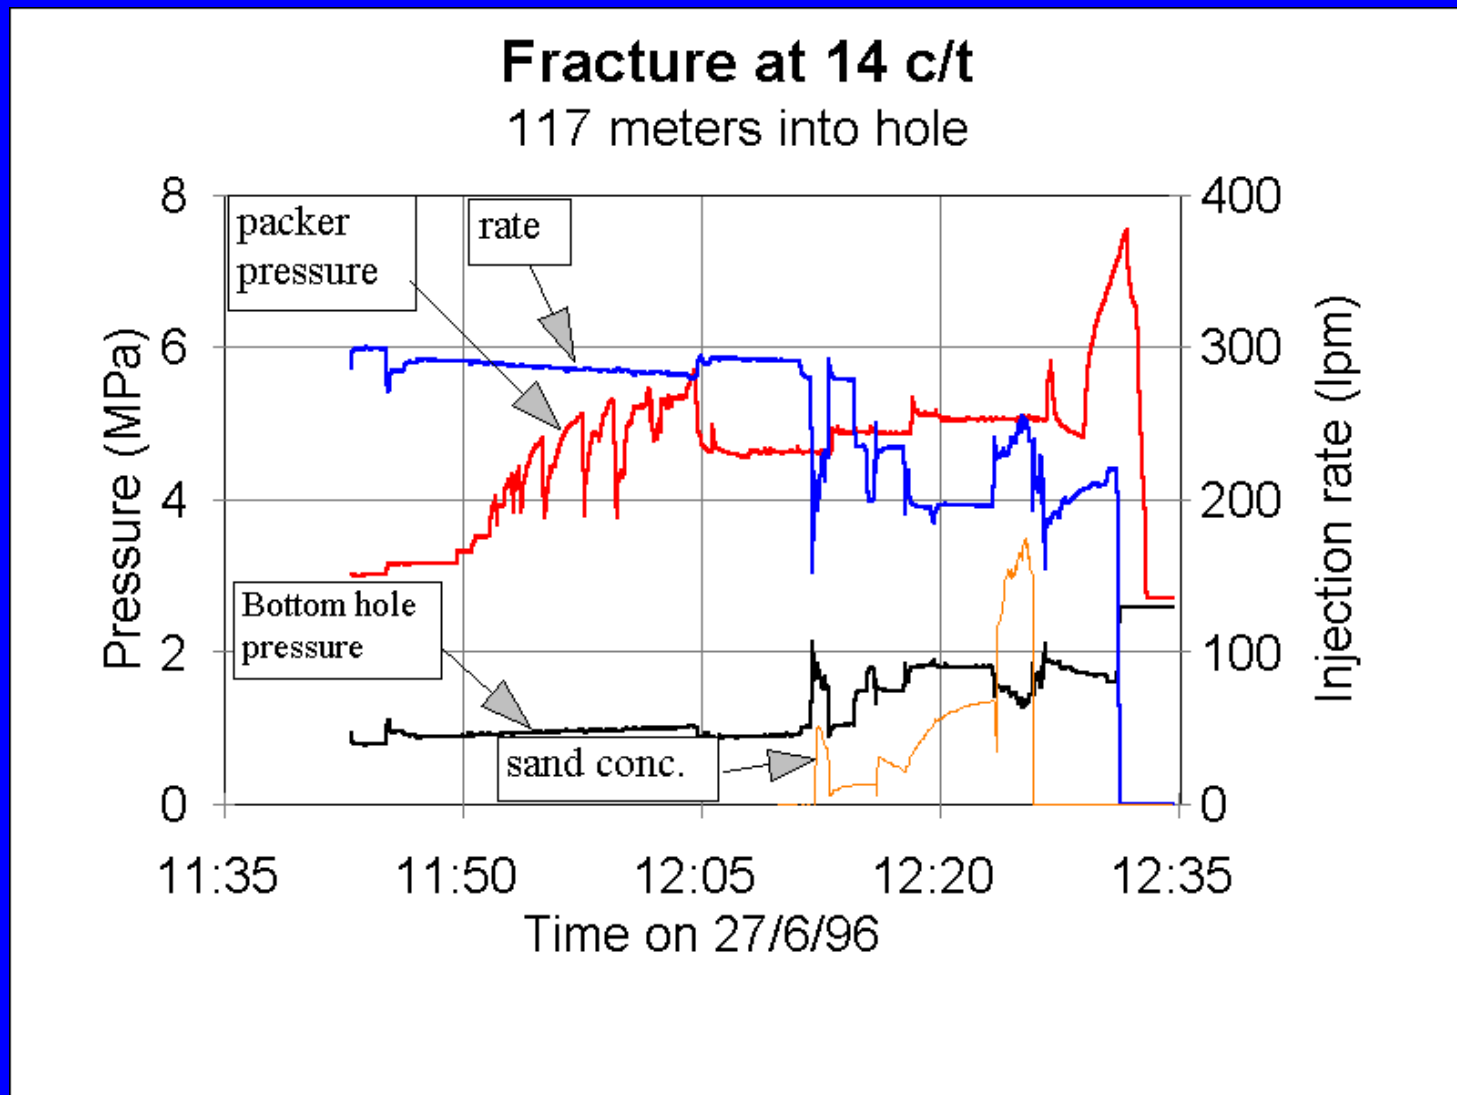
Pressure, injection rate and packer pressure during Injection at 117 m in horizontal drain hole.

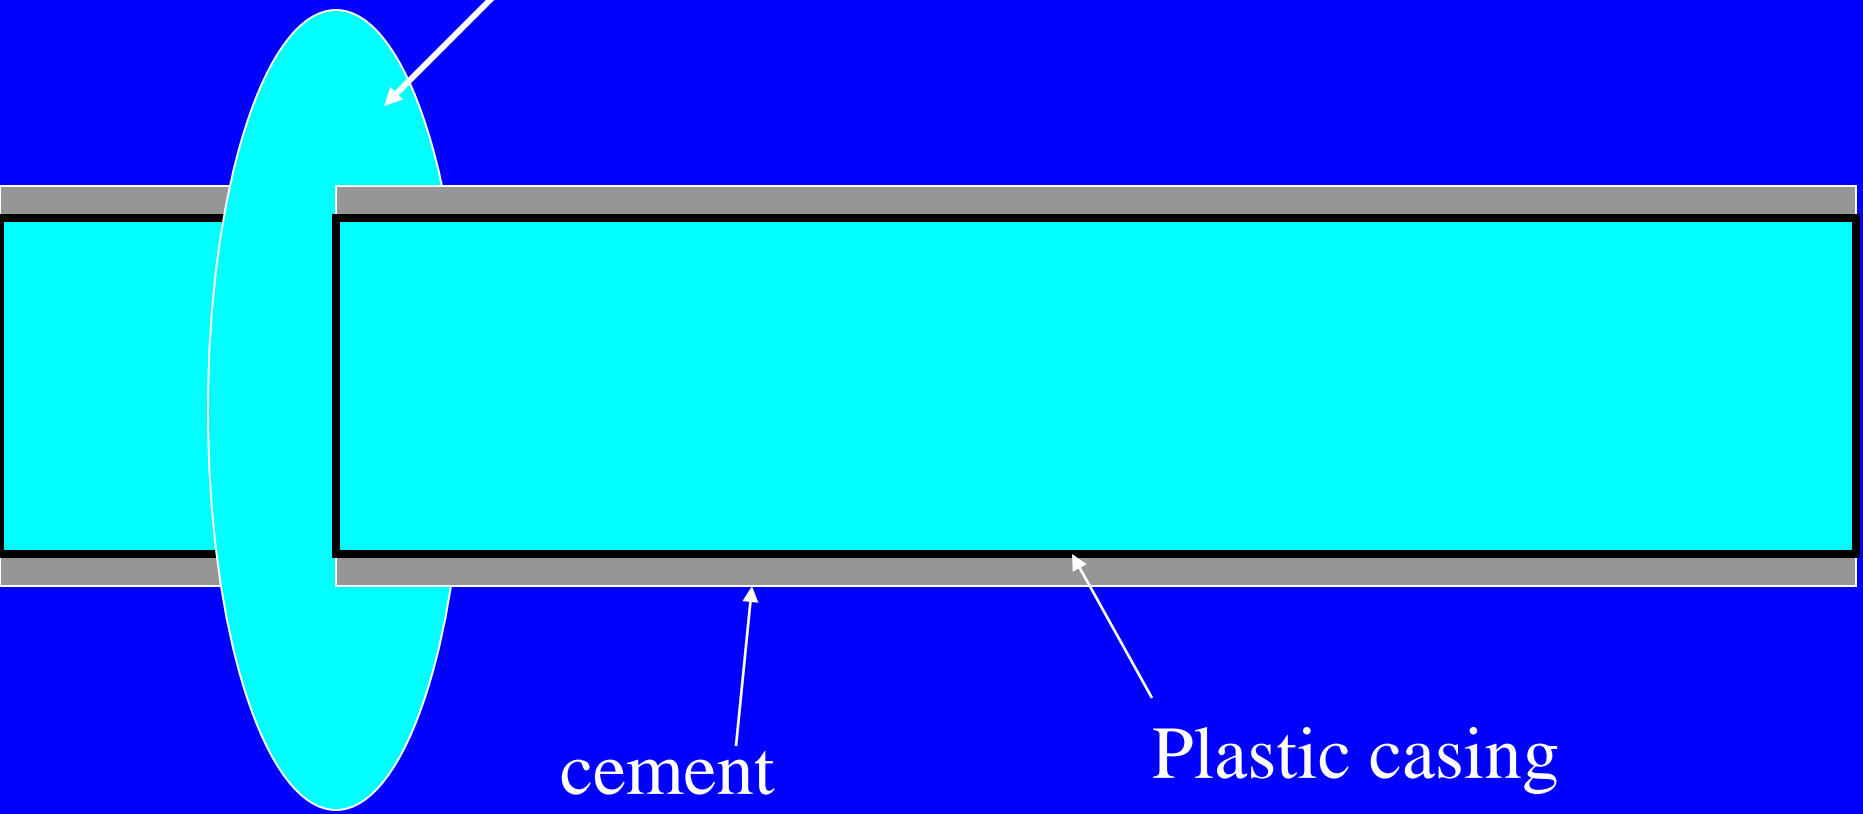
Water jetting of
radial slot.
