OUTBURSTS AT COLLINSVILLE — A CASE STUDY

ABSTRACT

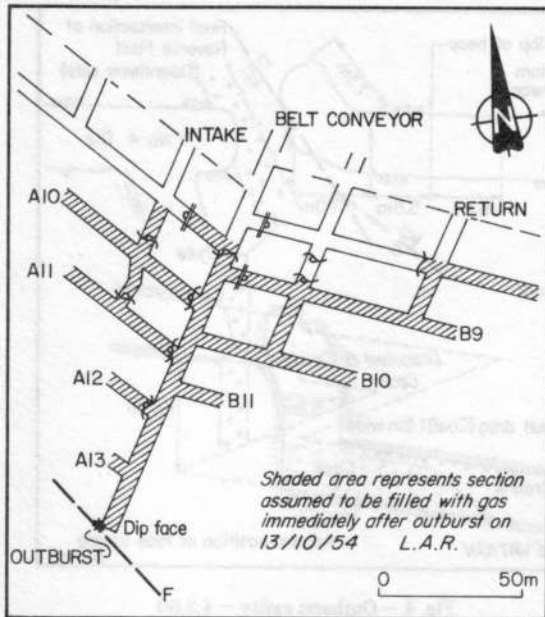
Fig. 2 - No. 1 State Mine Dip Workings

The death of all seven men was caused by asphyxiation in an atmosphere of carbon dioxide (Q.G.M.J. 1954). The gas released backed up against the ventilation to A9 level and went to level B6 on the return side. See figure 2. A dirty grey haze was reported immediately after the outburst. This haze was thought to be caused by condensation as the warm mine air was cooled by the expanding carbon dioxide gas.

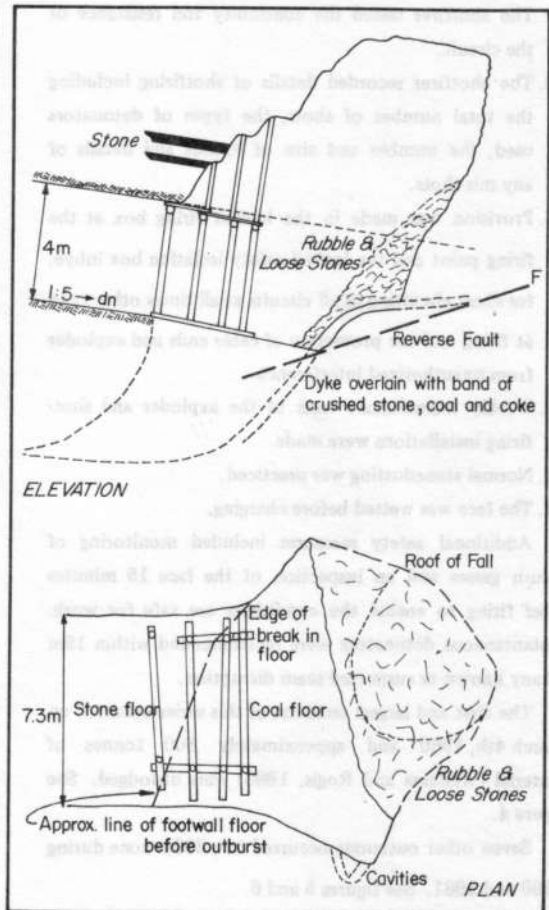
Fig. 3 - Outburst cavity - 13.10.54
(after Rogers, 1955 internal report)

A reverse fault with a throw of nine metres up ahead of the working face intersected a steeply dipping normal fault. A dyke also occurred in this area. See figure 3.

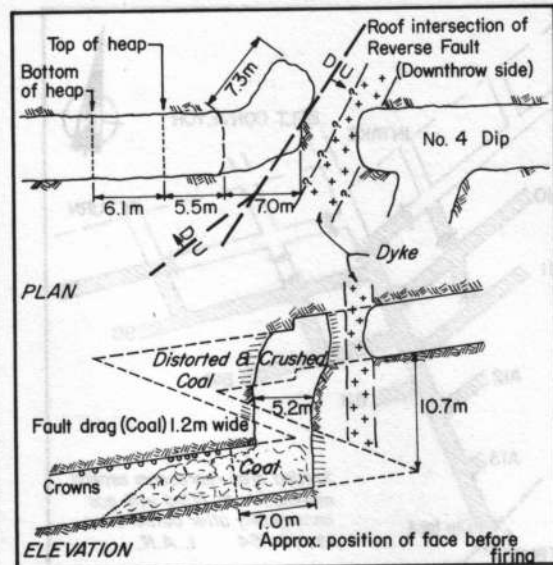
Fig. 4 — Outburst cavity — 4.3.60
(after Ogg, 1960, State Mine internal report)

The first and largest outburst of this series occurred on March 4th, 1960 and approximately 800 tonnes of material (Williams and Rogis, 1980) were dislodged. See figure 4.

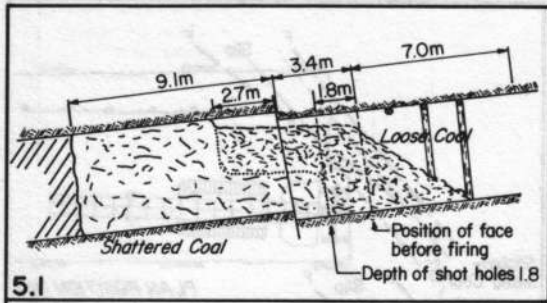
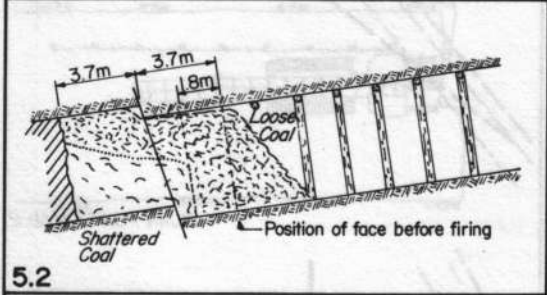
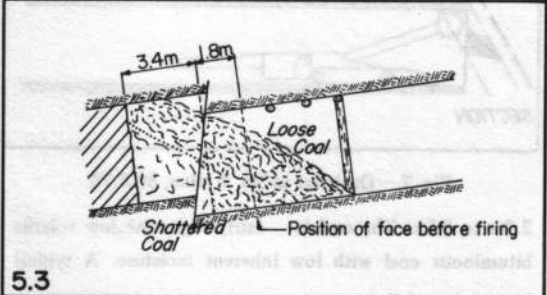
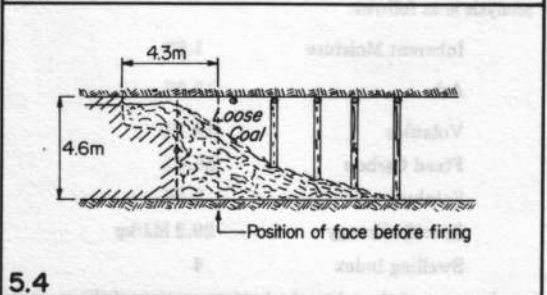
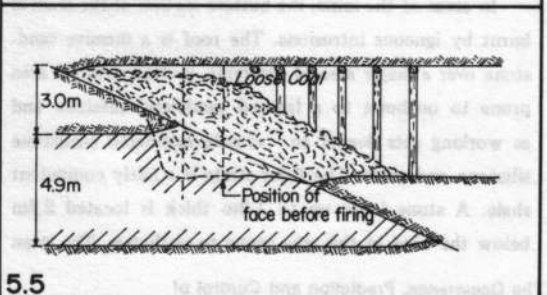
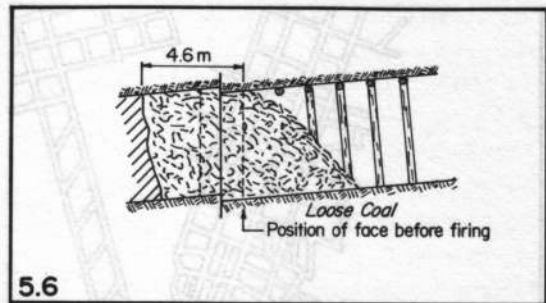
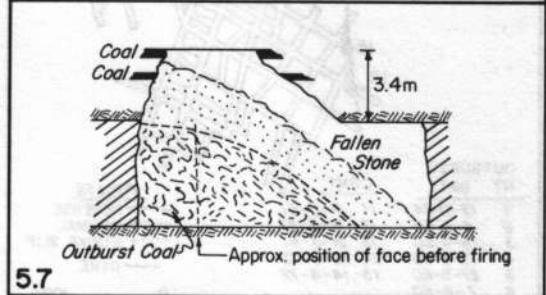
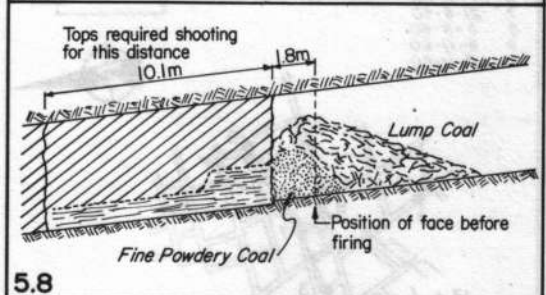
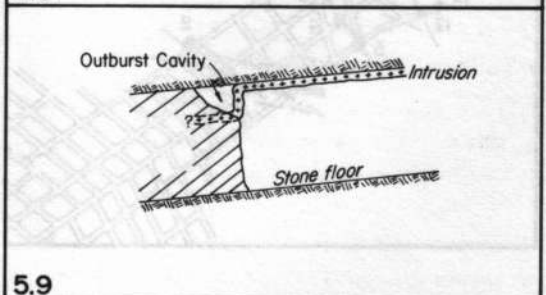
Fig 5 — Outburst cavities in No. 1 State Mine (after Ogg, 1960 and 1961, State Mine internal reports)

Seven other outbursts occurred in a 300m zone during 1960 and 1961. See figures 5 and 6.

These outbursts were triggered using inducer shot firing without injury. The drivage was slow and deteriorating roof conditions caused these workings to be abandoned in 1961.

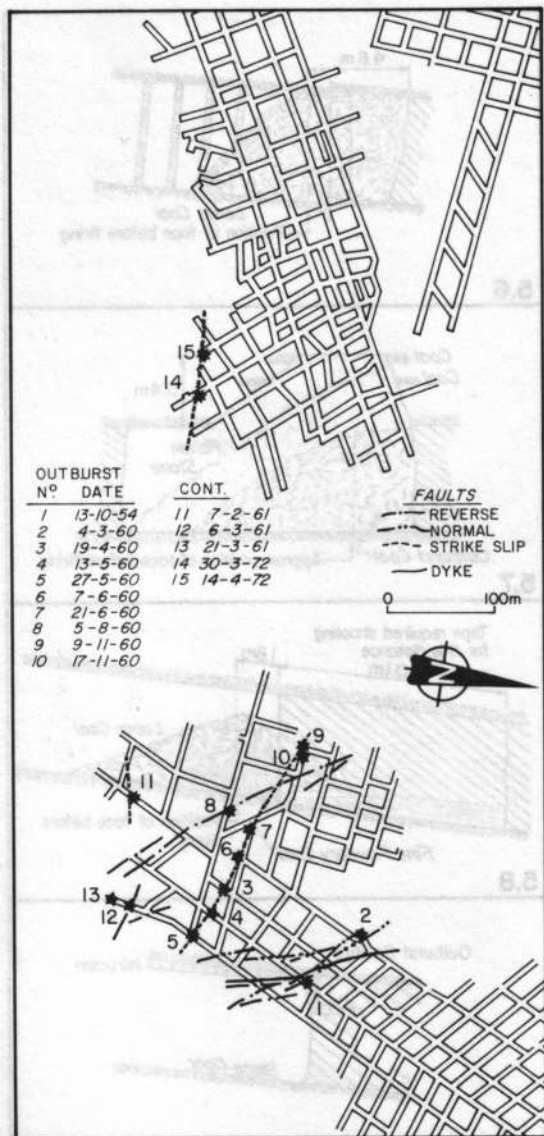
Fig. 6 — Outburst locations, No. 1 State Mine and No. 3 Mine

Mining at the No. 3 mine was generally in conditions considered as being outburst free. In the early 70's while mining the deeper parts of the Bowen seam near the outburst area in the old State Mine, two small outbursts were encountered. See figure 6.

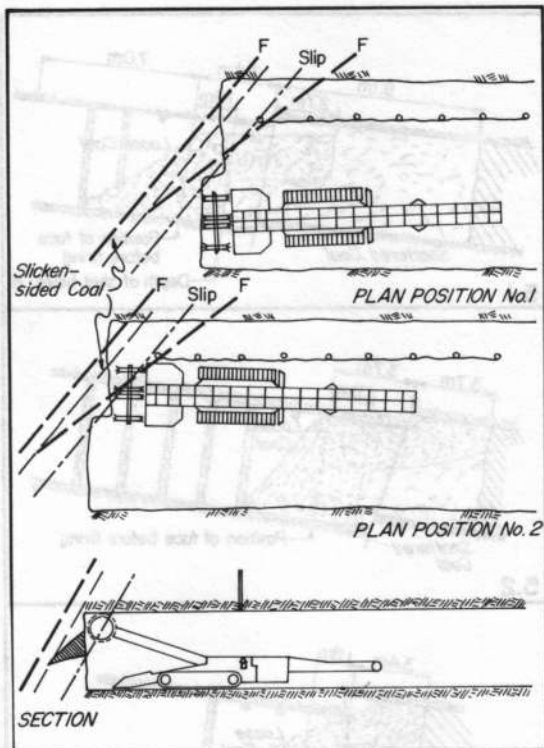
Fig. 7 — Outburst in No. 3 Mine, 30.3.72

The gas emission values (method by Hargraves, 1963) were generally below $0.5\text{m}^3/\text{g}$ and the area considered outburst free. In the deeper cover (240m) in the south-eastern section of the workings the emission values rose to $0.75\text{m}^3/\text{g}$ and up to $1\text{g}/\text{cc}$. Two small outbursts occurred in this area where the drivage intersected a strike slip fault. See figure 7.

As continuous miners were used, the outbursts occurred with men at the face. This caused some alarm. The section was difficult to work and was subsequently abandoned.

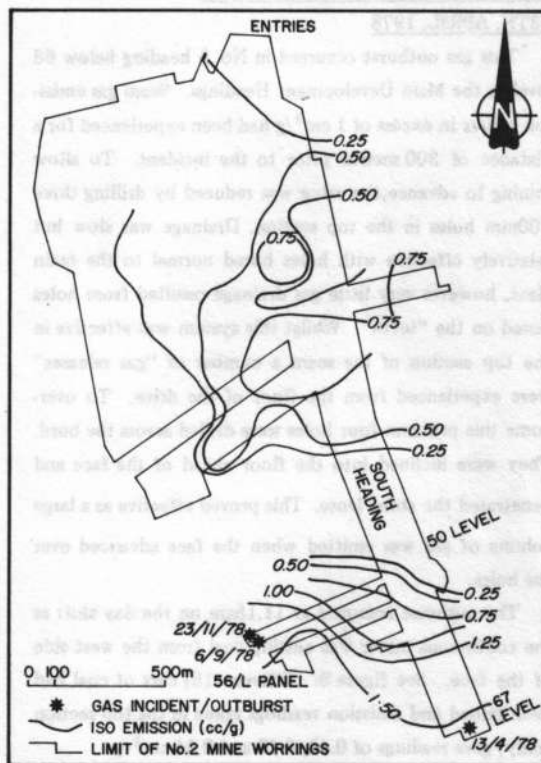
Fig. 8 — Outburst locations and gas emission in No. 2 Mine

tion was upgraded by the installation of a second axial-flow fan. Although the headings had been standing for such a length of time and gas had continually been given off, emission values increased at a faster rate than expected and were up to 0.35cm³/g within one pillar length. After mining through this zone emission values fell back to less than 0.10cm³/g and mining advanced, to 59 level (250m Cover) before values rose again. At this point the seam section and roof condition also changed. See figure 8.

Two of the six outbursts occurring in this area contained coal. The combined gas and coal outbursts occurred in a panel heading being driven west from the main development and at the site of a 6 metre reverse fault. The gas outburst occurred in the main development headings, with gas being emitted from the floor of the working section accompanied by floor heave. Each outburst was adjacent to a geological disturbance. The occurrence of one of the gas outbursts and the two gas and coal outbursts are described in the next section of the paper. See

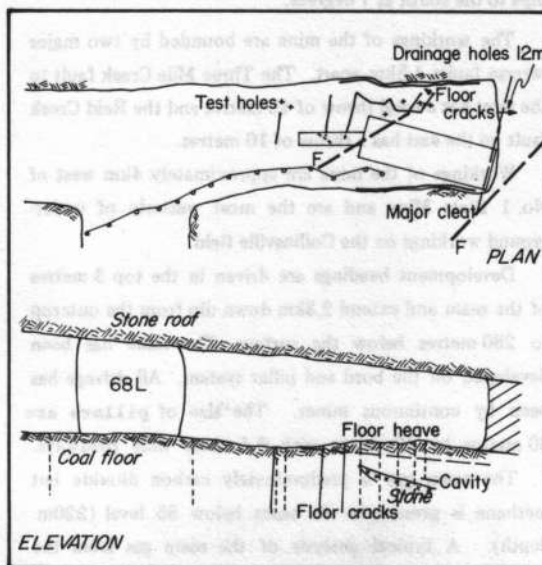
Fig. 9 — Gas emission site 13.4.78

The outburst occurred at 11.15am on the day shift as the continuous miner was cutting coal from the west side of the face. See figure 9. Fifteen (15) cars of coal had been mined and emission readings taken in the top section (only) gave readings of 0.42, 0.47 and $0.34 \text{ cm}^3/\text{g}$.

Ventilation at the face was $5.1 \text{ m}^3/\text{sec}$. On inspection it was evident the gas had been emitted from floor cracks associated with a floor heave of approximately 0.6 metres. It was not possible to determine the volume of gas given off. A gas emission taken in the face after the outburst gave $0.51 \text{ cm}^3/\text{g}$.

Mining bottom coal at the site exposed a reverse fault with an upthrow of 0.95 metres. This fault had been intersected 40 metres back from the face in the top section of the seam. It was proven that floor holes had not been bored in this area.

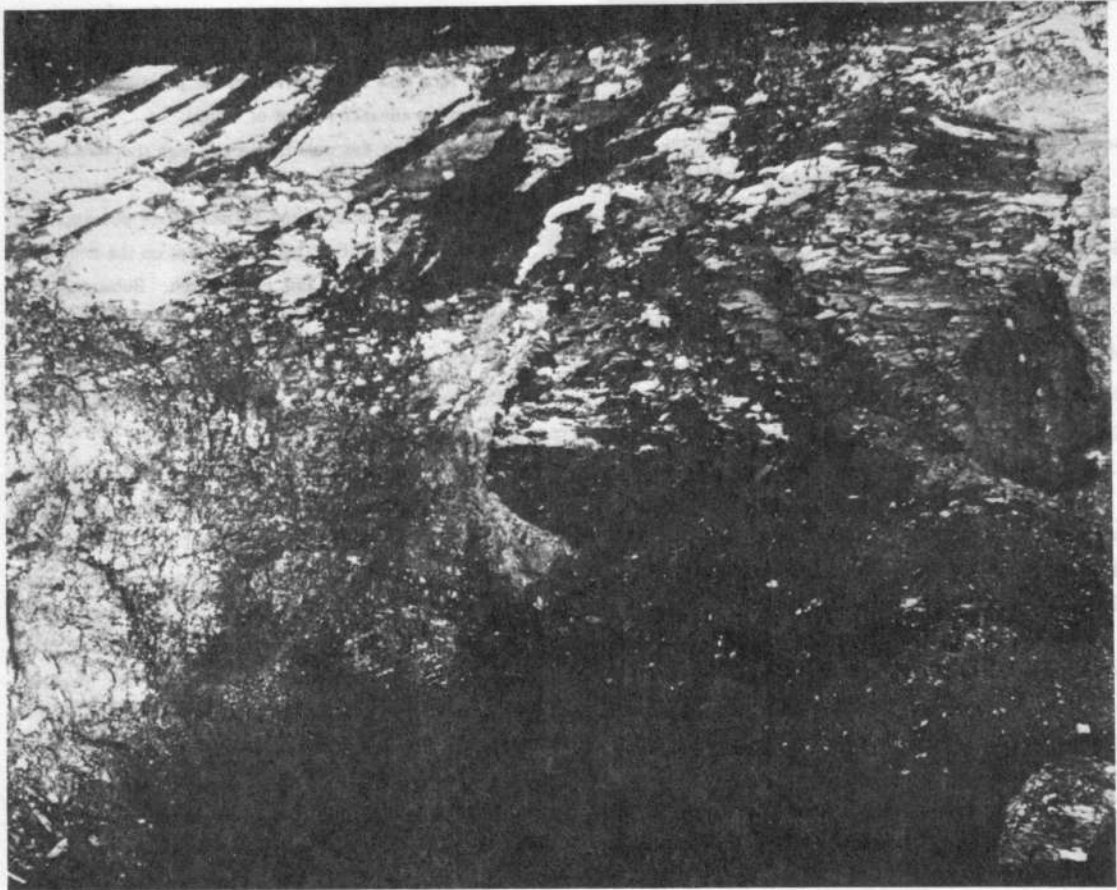
Fig. 10 — Outburst cavity, 6.9.78

The continuous miner was cutting coal with the head against the roof when the outburst occurred and no doubt this restricted the blast. See Figs. 10 and 11.

No warning noise was heard by the crew. They left the face when coal stalled the conveyor on the miner and spilled out over the head. 2420m³ of gas was given off in 3.5 hours following the outburst.

After this outburst, the additional measures were adopted for mining in areas where the seam gas emission exceeded 1 cm³/g.

1. Three pilot holes were maintained 15 metres in advance of the face. The rib holes were flanked slightly outward.

2. A minimum air ventilation of 9.5m³/sec was maintained.
3. The face was kept as square as practicable with a maximum advance per cut of 1.35m.
4. Housekeeping was maintained at a high standard in the face area.
5. Siebe Gorman compressed air units were purchased to replace AUER 16B. These were kept on the machines and in a box at the last cut-through. Subsequently, Medic Air bottles were installed on the continuous miners.

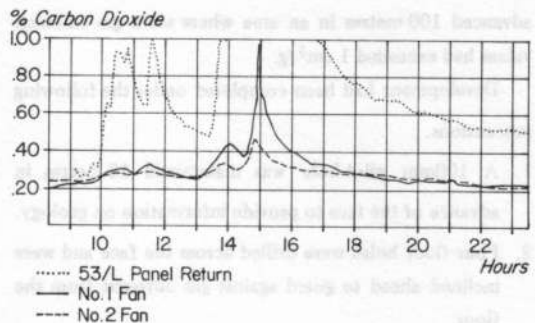
Fig. 12 — Gas chart, 6.9.78

Recordings on the M.S.A. gas monitor indicated a peak of 1% CO₂ at the main ventilating fans and a level in excess of 1% for three hours in the panel return. See gas chart Figure 12. Face ventilation at the time was 4.6m³/sec.

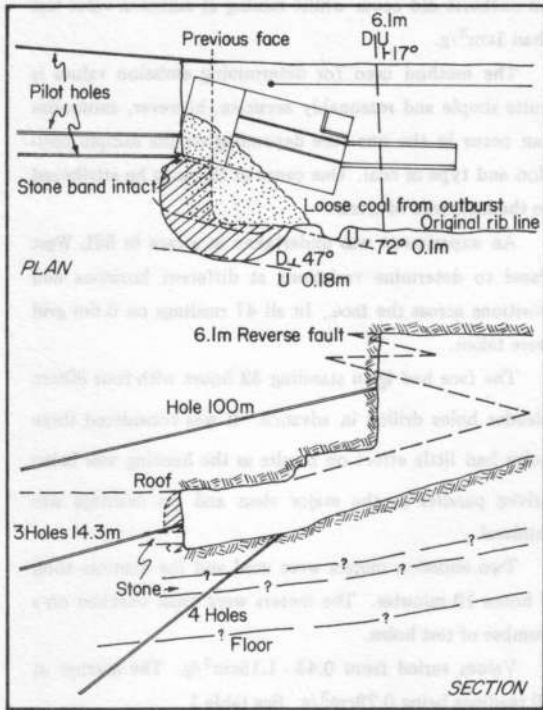
Fig. 13 - Outburst, 23.11.78

This outburst occurred on 53 level during the afternoon shift. The level had penetrated into a six metre reverse down throw fault and had advanced approximately nine metres under the lip. This is the same fault from which the outburst occurred in 53½ level on the 6th September, 1978. See Figures 8 and 13. The previous shift had reported the coal as being very disturbed in the interval 0.8 to 1.3 metres below the roof. The entire face was very "drummy". Difficulty was experienced in drilling the gas emission holes as the drill kept bogging in the soft coal. There was an increase in gas activity at the end of the day shift and the gas emission had been 0.93 cm³/g.

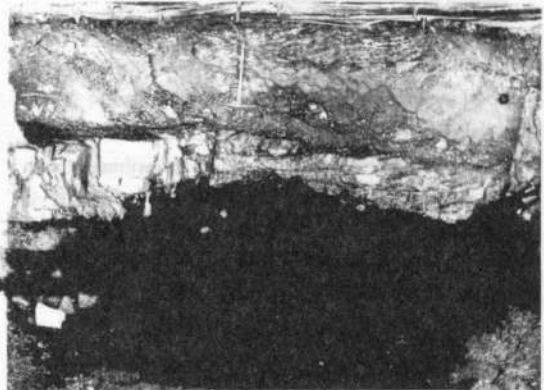
Fig. 14 - Outburst cavity, 23.11.78

Approximately 19 tonnes of outburst coal was recovered.

The outburst was confined to the top section of coal above the stone lense and extended back approximately 3 metres from the original rib line. A small strike slip fault with a throw of 100mm was evident at the site after the outburst.

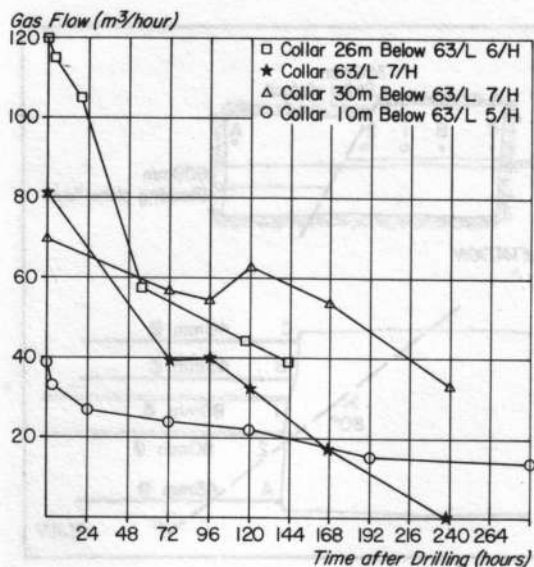
Fig. 19 — Flow from bleeder holes (80mm dia)

Despite the flow variations, it was possible to predict with considerable certainty when a site could be mined. This is illustrated by the curves in Figure 19. Flow rates

decreased steeply for the first 72 hours, after which the curves flattened out. At the point, where the curves levelled, water would begin to flow from the face holes. It was found that once this water flow commenced, it was possible to mine to the extent of the holes before obtaining high gas emission values.

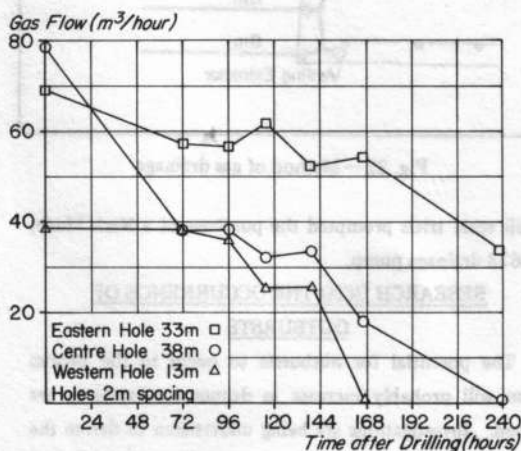
Fig. 20 — Flow from bleeder holes in No. 7 heading below 63 level

As well as the variations in flows on different faces, there was other differences as shown by figure 20 which indicates variations in flows recorded on three holes drilled parallel and in the same horizon on the same face.

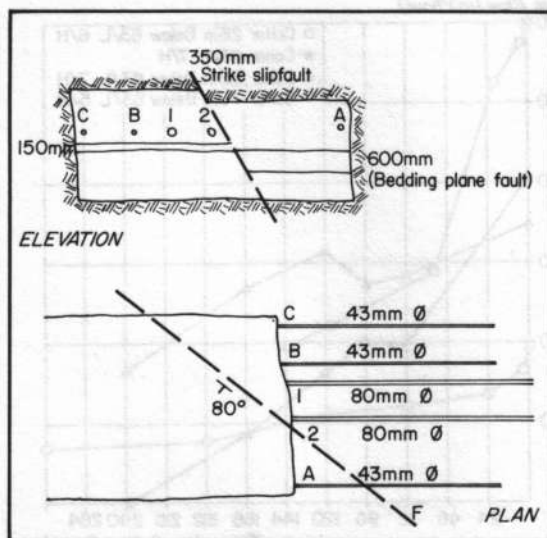
Fig. 21 — Gas drainage site 53 level west

Small scale tests were conducted on gas drainage during 1978 in 53L West Panel where previously bleeder holes and pulsed infusion shotfiring had failed to reduce the emission values. See figure 21. Driveage in this panel is parallel to the main cleat of the seam and consequently presented the most difficult conditions for trials.

In one case following the failure of pulsed infusion shotfiring, gas drainage methods lowered the emission values from $1.08 \text{ cm}^3/\text{g}$ to $0.77 \text{ cm}^3/\text{g}$ inside two hours and mining was able to advance 6 metres before values again rose in excess of $1 \text{ cm}^3/\text{g}$.
