SUMMARY OF INVESTIGATIONS INTO
APPIN COLLIERY EXPLOSION

ABSTRACT

At 11 p.m. on Tuesday, 24th July 1979, an explosion of methane gas in a three heading development panel at Appin Colliery resulted in the deaths of fourteen men.

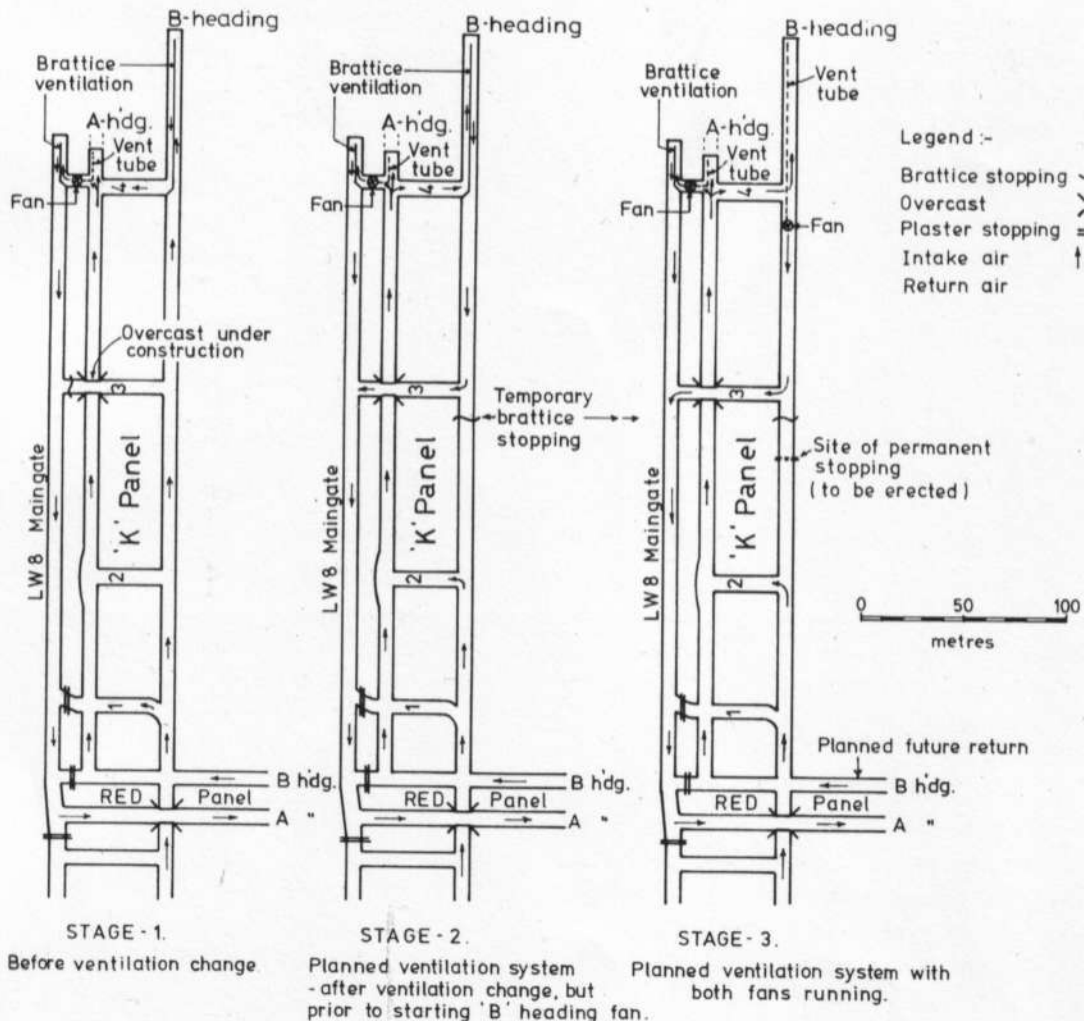
Fig. 2. Changeover Plan

The conditions in the panel prior to the changeover and the intended effect of the changeover are shown in Fig. 2. Stage 1 shows the panel layout on the morning of Tuesday 24th July with A and B headings as intakes and L.8 maingate as the return. The overcast at the intersection of No. 3 cut through and A heading was being built. L.8 maingate stub inbye of No. 4 cut through was brattice ventilated,

A heading stub was ventilated by an exhaust fan situated in the cut through and B heading which had been driven forward 70 m as an intake stub was ventilated by brattice. Stage 2 shows the intended post changeover ventilation. This was to be achieved by erection of a temporary brattice stopping in B heading outbye No. 3 cut through and removal of the brattice in No. 3 cut through. A fan with associated vent tubes had been placed in B heading and Stage 3 shows the effect of replacing the B stub brattice by that fan, a step which was necessary before both miners could be operated.

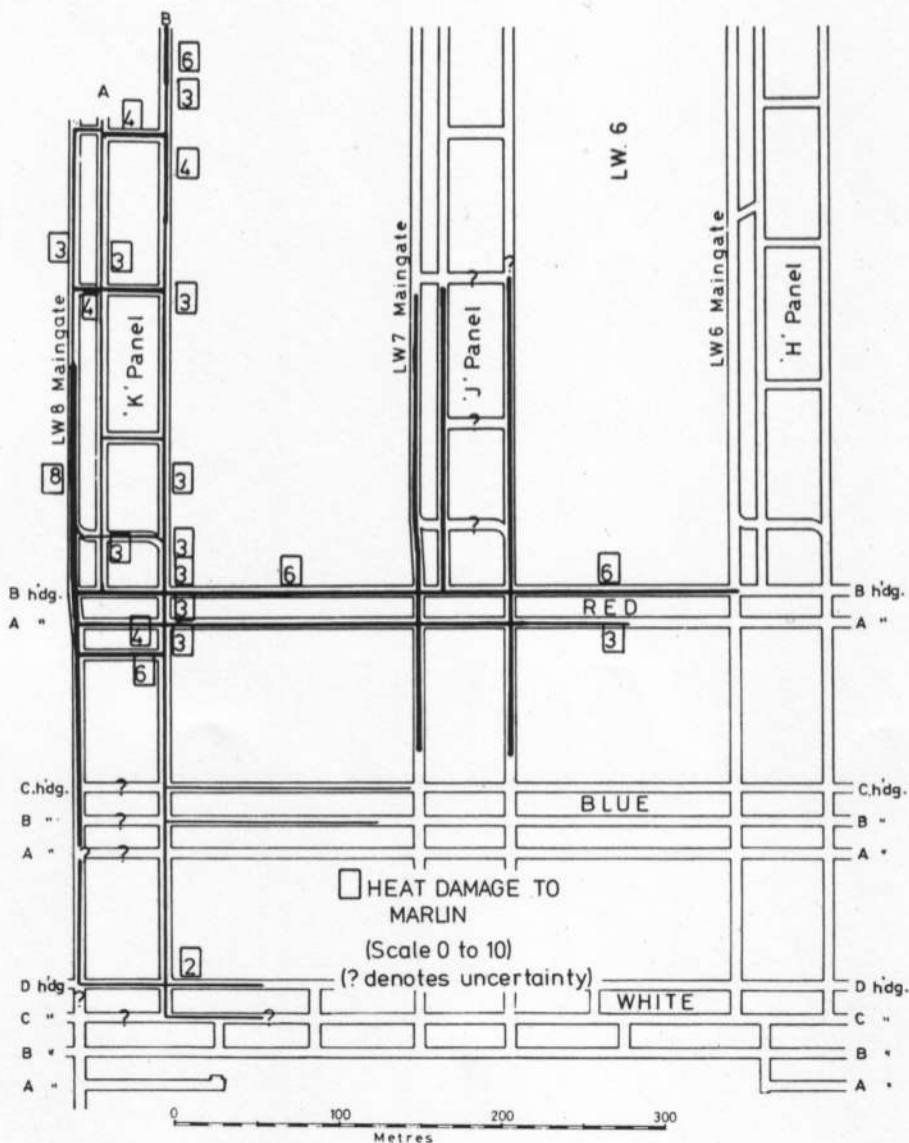
Fig. 5. Extent of Flame Travel

Fig. 5 adapted from Ellis (1979) shows the extent of probable flame travel determined after examination of heat damage to marlin and after calculating the volatile content of coal matter in roadways. In discussing the flame travel Ellis (1979) commented "The extent of flame suggests the involvement of coal dust." and he

"The degree of damage produced in B heading near the face and back past No. 4 cut through suggests a violent explosion resulting from ignition of a body of gas near its inbye end.

If this conclusion is correct, it limits the possible locations of ignition of the methane to either the face, or a point from which flame could travel to the face. The vent tubes provided one path by which flame could travel to the face and there ignite a body of gas at its inbye end. I am uncertain that a roof layer of methane could behave in this way. It would seem that flame travelling via a roof layer of methane must ignite a body of gas at its outbye end. It would then produce an explosion which was incapable of initiating a coal dust explosion."
