## Appin Colliery Explosion Reassessed

**Bob Kininmonth, retired Senior Inspector of Coal Mines**

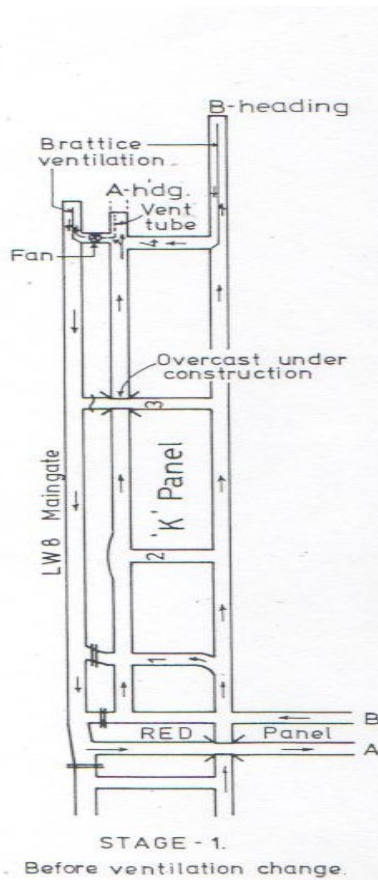
Figure 1. Original Layout

Figure 1 called stage 1 shows the original layout with an overcast being built at 3C/T in preparation for the changeover.

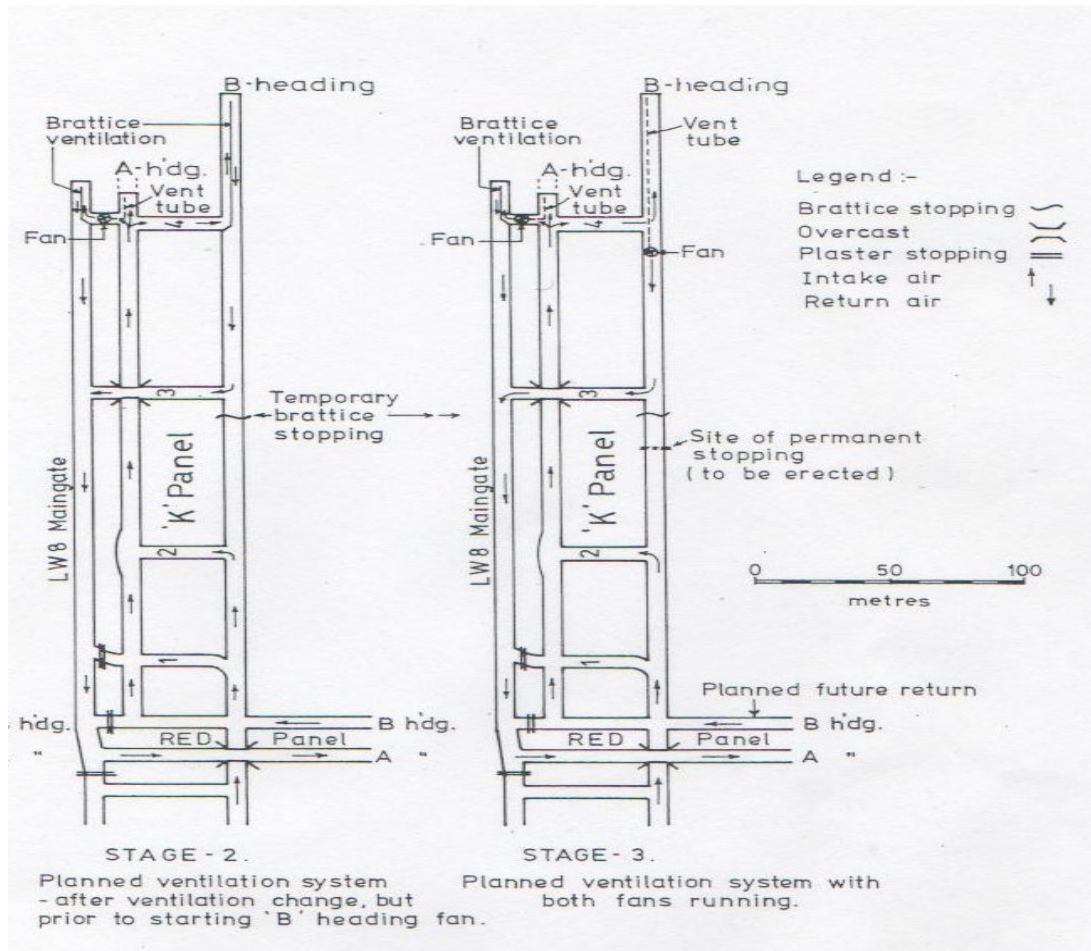
Figure 2.Planned Procedure

Figure 2 shows the intended changeover procedure with stage 2 portraying the establishment of the changed airflow by completion of the overcast, erection of a brattice stopping in B heading outbye of 3C/T and removal of the stopping in 3 C/T. Stage 3 shows the intended completion of the changeover with a fan operating in B heading

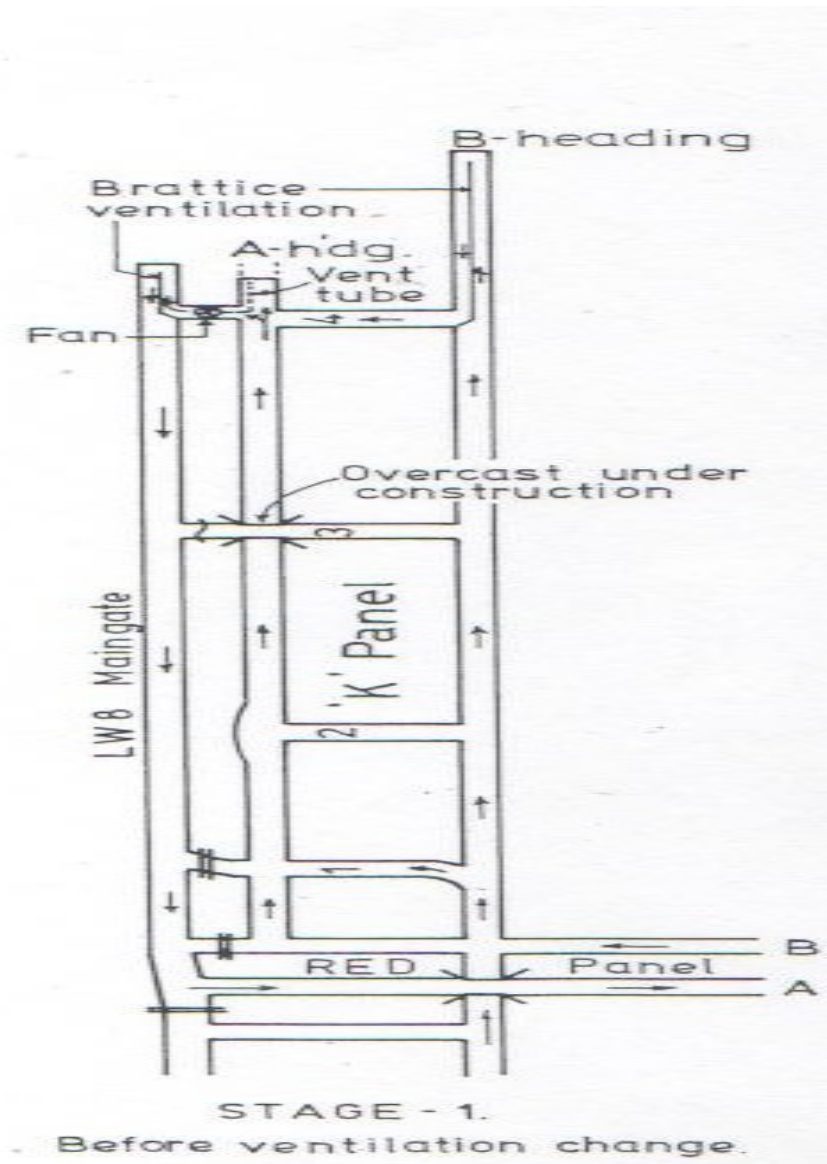
Figure 3. Position At End Of Shift Before The Explosion

At the end of the shift before the explosion a deputy sent to assess progress found that a brattice stopping had been erected in B heading and though it had been stapled on the wrong side of the props was not considered to be a problem. However he was concerned that there appeared to be considerable leakage coming from the overcast. Although he had been expected to remove the 3 C/T brattice he did not do so.

Figure 3 shows the situation as it was last seen.
