OUTBURSTS AT COLLINSVILLE — A CASE STUDY

ABSTRACT

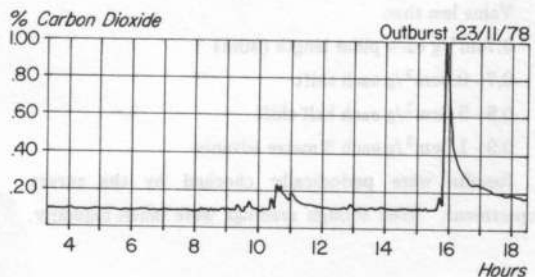
Fig. 15 - Gas chart from No. 1 Fan 23.11.78

Ventilation at the face was $13.8\text{m}^3/\text{sec}$. Recording from the M.S.A. gas monitor showed CO_2 in excess of 1% for a period of 18 minutes at a sample point in the panel return. See the gas chart figure 15. 260m^3 of gas was emitted in twenty-five minutes and 940m^3 over six hours.

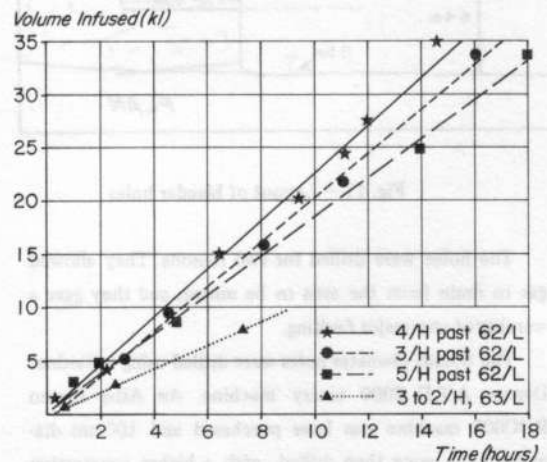
Fig. 16 — Rates of Infusion

The infusion rate at dip sites averaged 2.2kl/hour, and at the one level site, 1.3kl/hour. See figure 16.

For the first hour from the commencement of infusion, gas activity from the flank holes and the entire face increased, until water began flowing from the flank holes. This water quickly increased in flow, until the flow rate

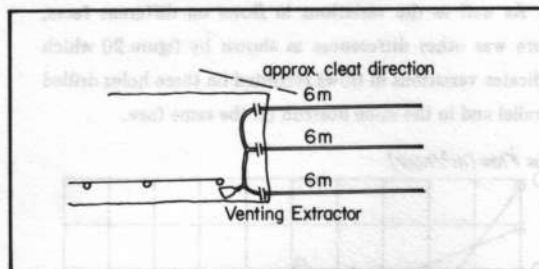
Fig. 22 — Method of gas drainage

Three 43mm holes were drilled across the face to a depth of 6 metres at mid-working height and approximately 2 metres spacing. Each hole was sealed using Stauff dilatible seals and coupled via a manifold to the Stauff Venturi duster. See figure 22.
