# GAS DRAINAGE EXPERIENCE AT THE NORTH GOONYELLA MINE

*ABSTRACT:* The North Goonyella Coal Mine has been owned in Joint Venture by RAG Australia Coal and Thiess NG Pty Ltd since November 2000. The mine is operated under contract by Thiess. Effective gas drainage is a fundamental requirement for the safe and efficient operation of the mine.

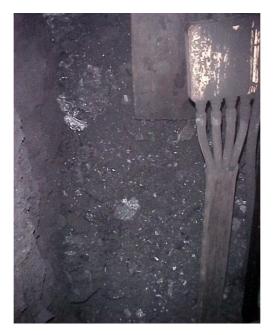
Fig 4 Material at Drill Rig

By the definition of an outburst as a "sudden release of coal and gas under pressure" the event was arguably not an outburst. Fig. 4 shows outburst material at the drill rig.

- 1. Approximately 6 tonnes of pulverized, dry coal loosened from the face.
- 2. No significant variation in mining conditions prior to the event.
- 3. Presence of an outburst "cone" in the roof of the cavity.
- 4. No sign of structure.
