## Hydraulic fracturing experiments in vertical boreholes in the German Creek coal seam

by  
R.G. Jeffrey<sup>1</sup>, J.R. Enever<sup>1</sup>, R. Phillips<sup>2</sup>, D. Moelle<sup>2</sup>,  
and S. Davidson<sup>3</sup>

<sup>1</sup>CSIRO Division of Geomechanics, <sup>2</sup>Capricorn Coal Management Pty Ltd, <sup>3</sup>North Queensland Energy Pty Ltd.

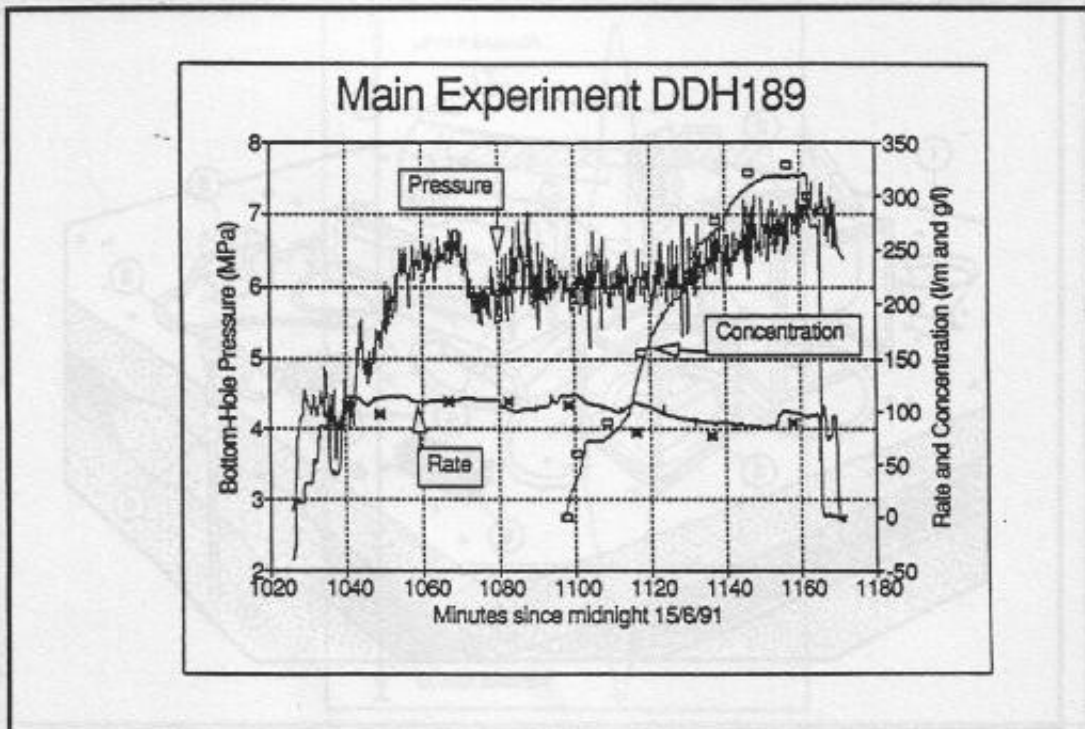
Figure 6. Treatment summary for DDH 189

Summary plots of pressure, injection rate, and proppant concentration in the fluid are shown in Figures 5, 6, and 7. A valve problem with the activator pump meant that no crosslinking occurred in the treatment in ECC 87 until about one quarter of the fluid had been injected. The rapid increase in pressure seen in Figure 5 at this point is associated with increased flow resistance, mostly in the fracture, to the crosslinked fluid compared with the non-crosslinked linear gel. The experiments are summarized in Table 6.

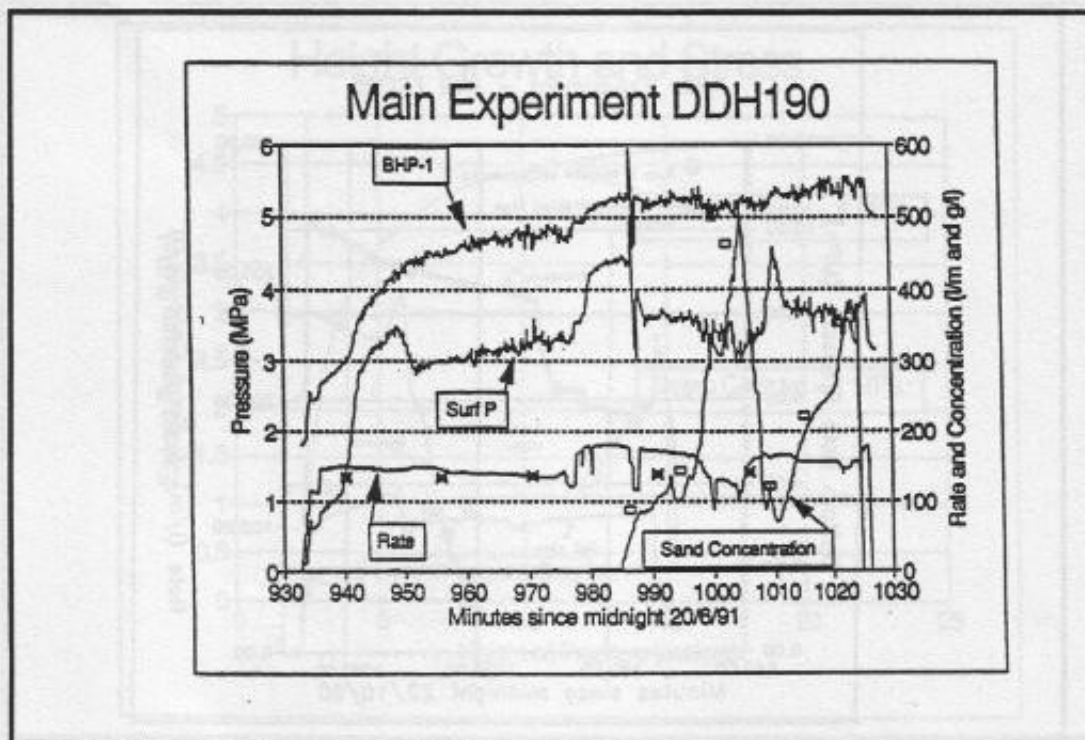
Figure 7. Treatment summary for DDH 190
