Whats happening at CENTRAL?

Ron Cassidy – Gas Drainage Engineer

LOCATION – CENTRAL COLLIERY

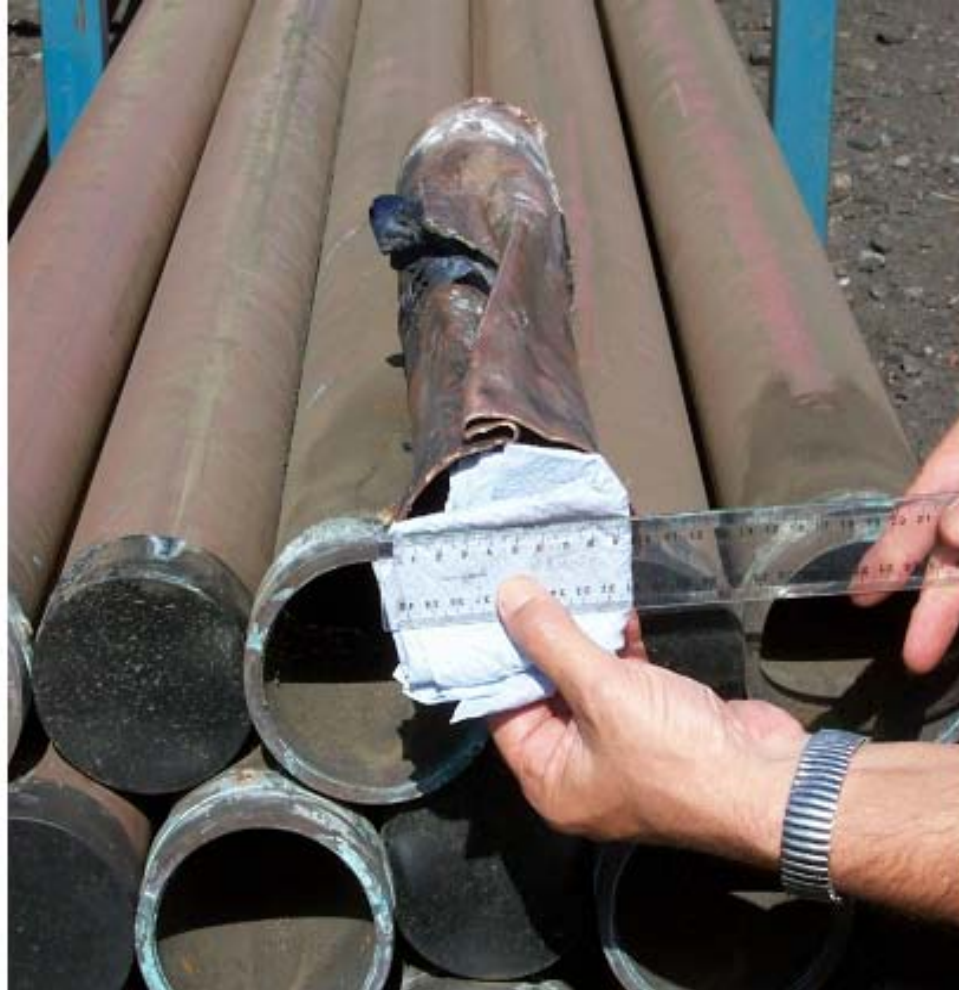
DEMOLISHED STANDPIPE

- DRILLED IN INTERBURDEN TO ALLOW CONDUIT FOR GAS
- COMMERCIAL ISSUES FROM DRILLING CONTRACTOR
- DRILLED SHORTER HOLES FROM TAILGATE
- ABUTMENT PRESSURE FROM ADJACENT GOAF DEMOLISHED STANDPIPES
- DRILLED FROM MAINGATE.
