NORTH GOONYELLA – STRUCTURAL CONTROLS ON PERMEABILITY

Harry Seitlinger

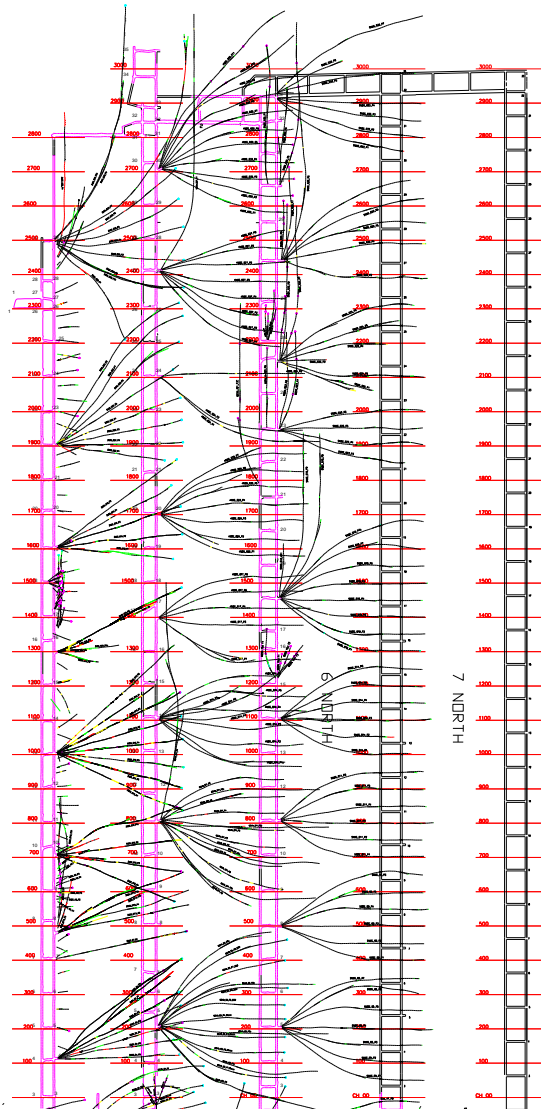
Close up of in-seam
drainage holes MG3N,
MG4N and MG5N. Note
fan pattern for MG3N and
candelabra pattern for
MG4N & MG5N

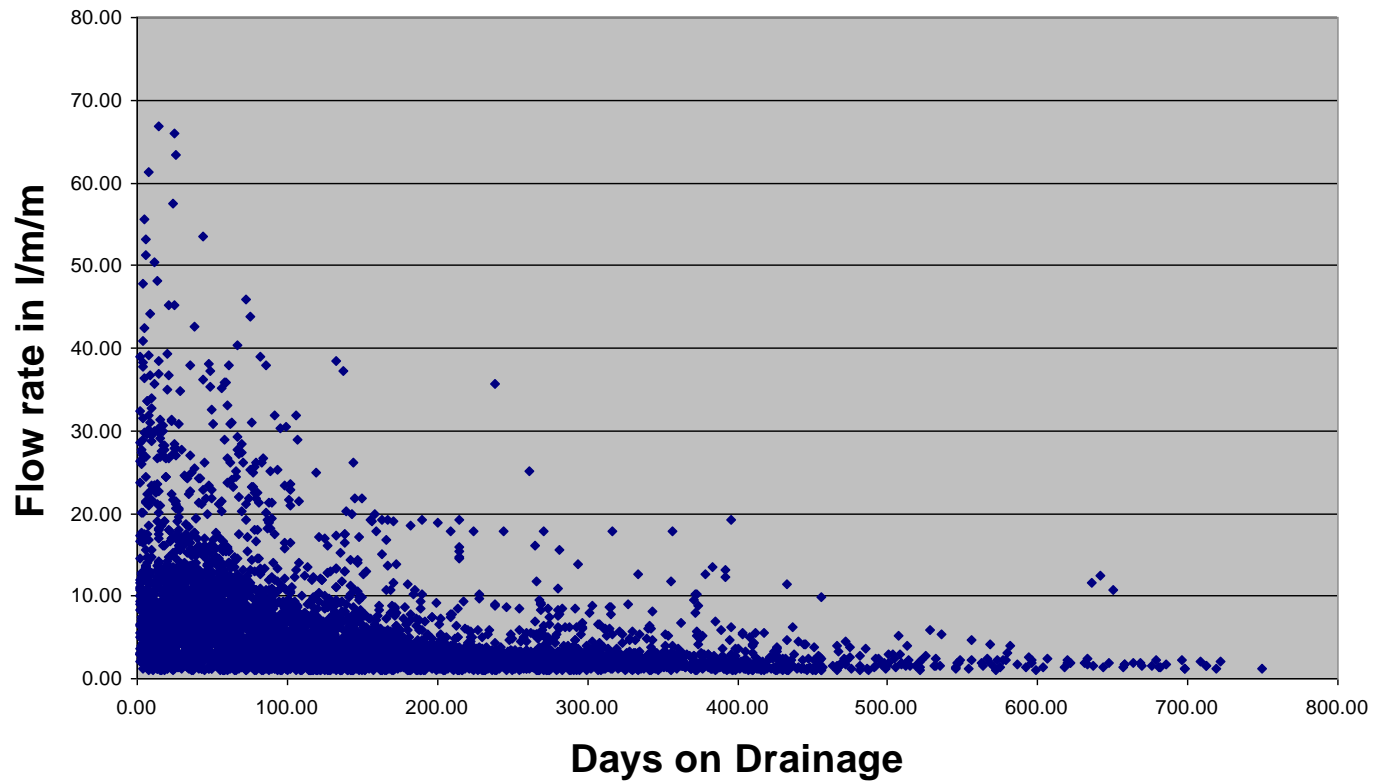
All Gas Flow data from all holes

One of the big problems with looking at all the data was that nothing stood out as being obvious. The data was then sorted into MG3N,4N & 5N separately. The graphs were then clipped to show only drainage times to Day 120 and max flow of 20 l/m/m. This helped only marginally. A separate datum was chosen for each gate road being **Day 20 for MG3N, Day 30 for MG4N** and **Day 40 for MG5N.**

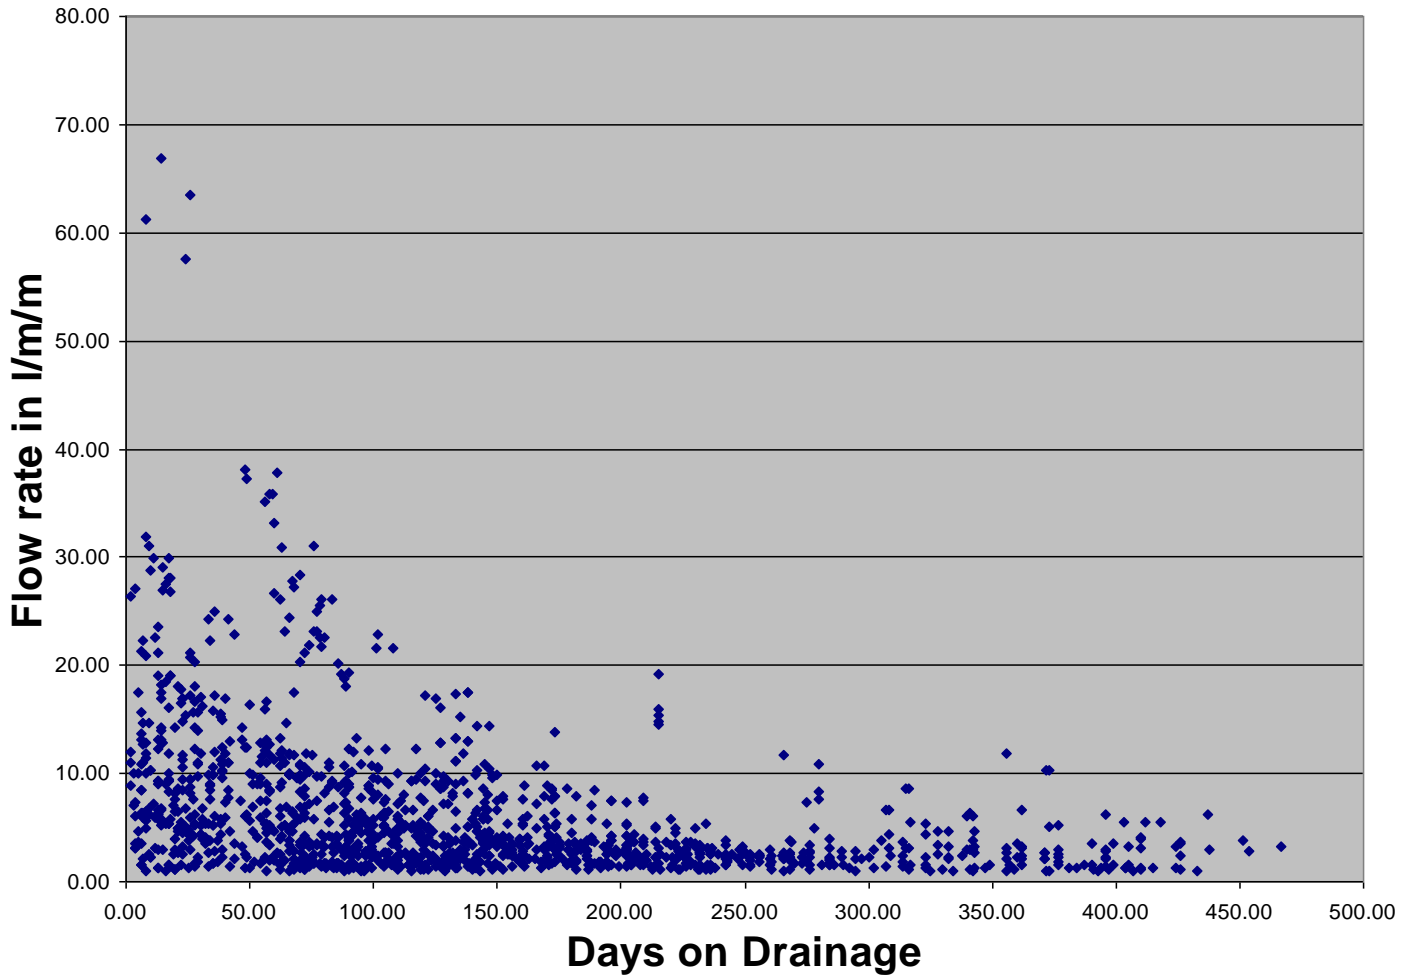
MG3N All data

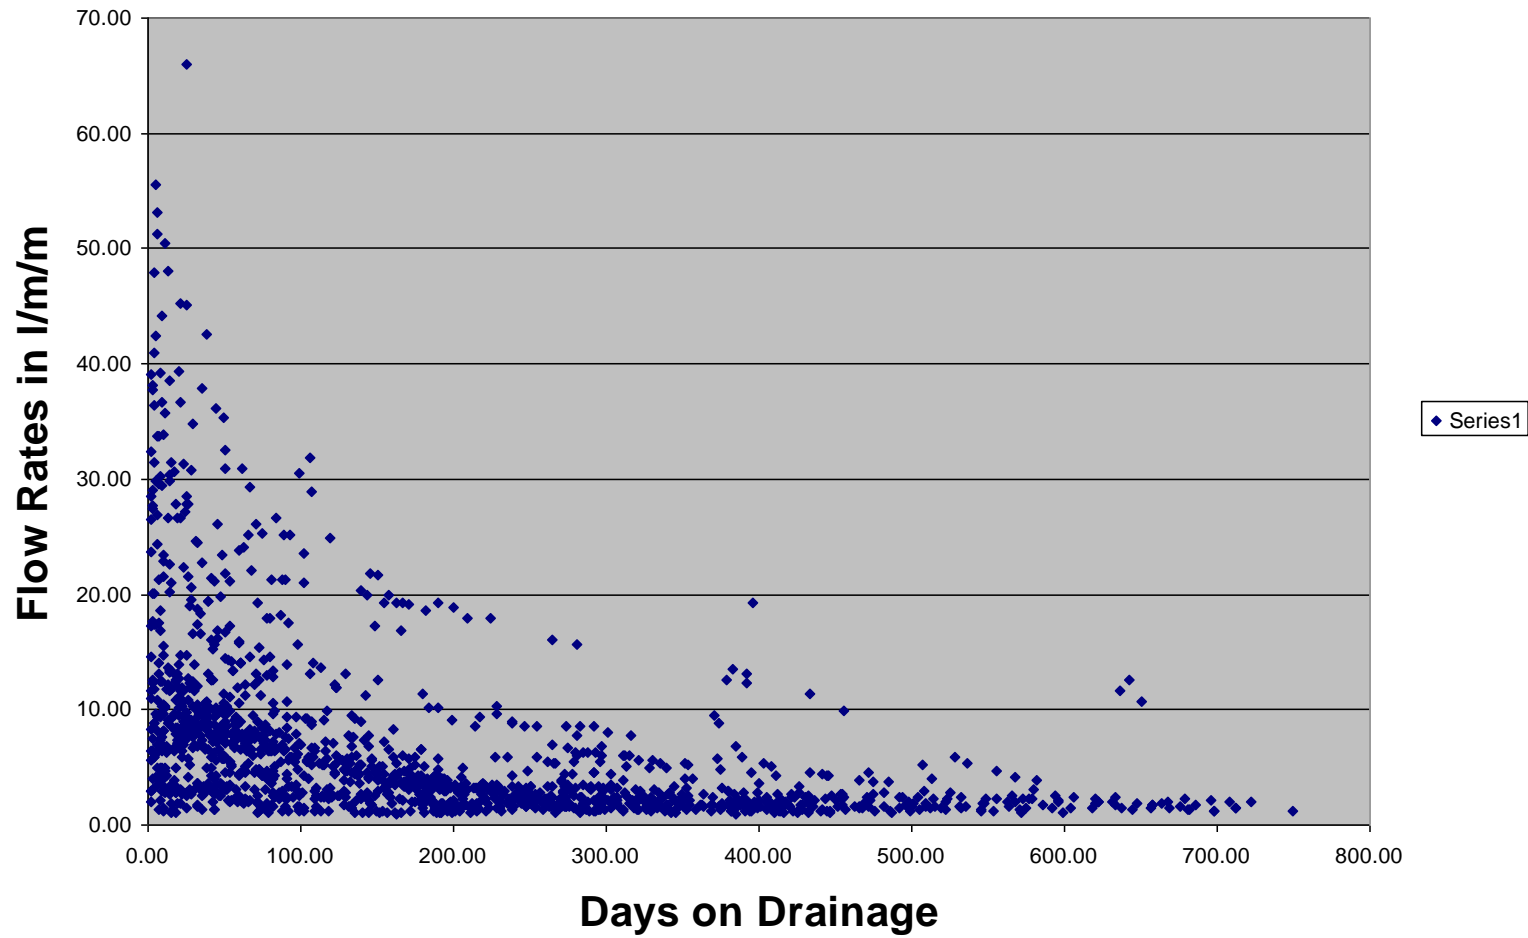
MG5N all Data

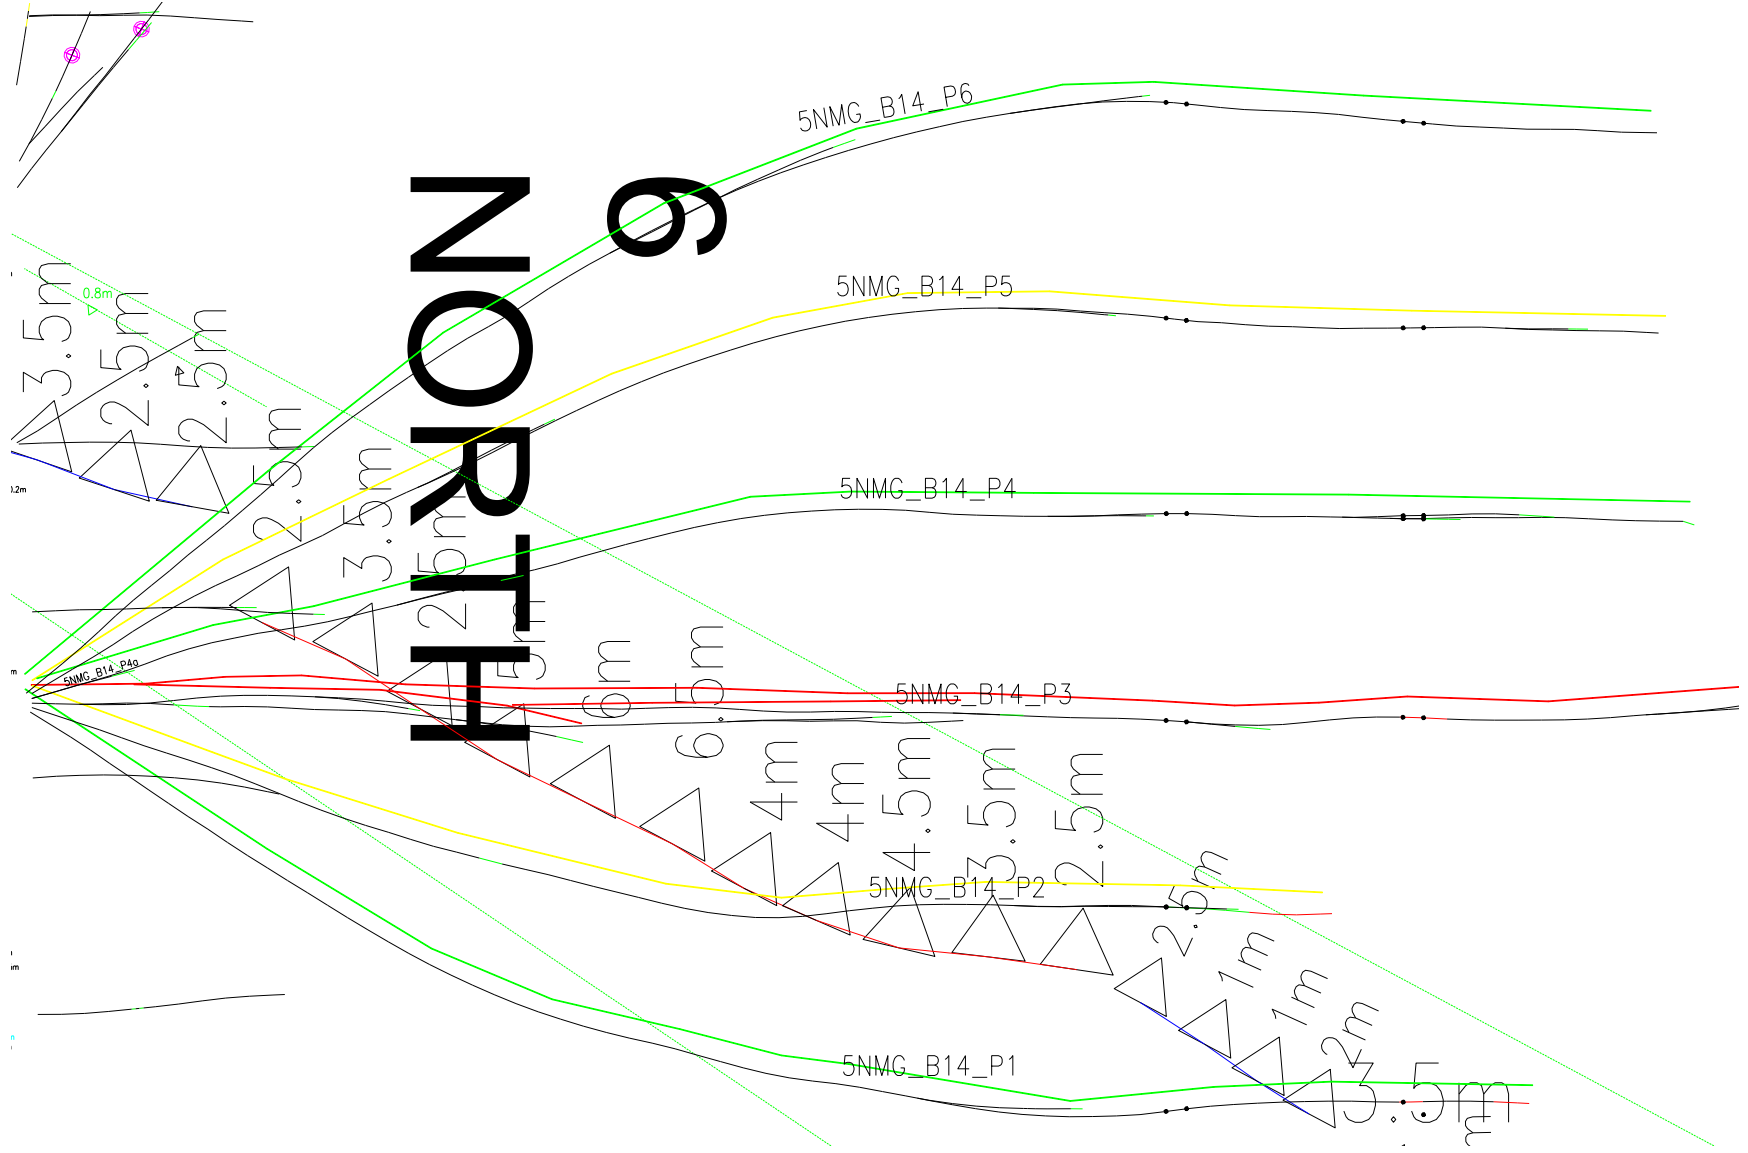
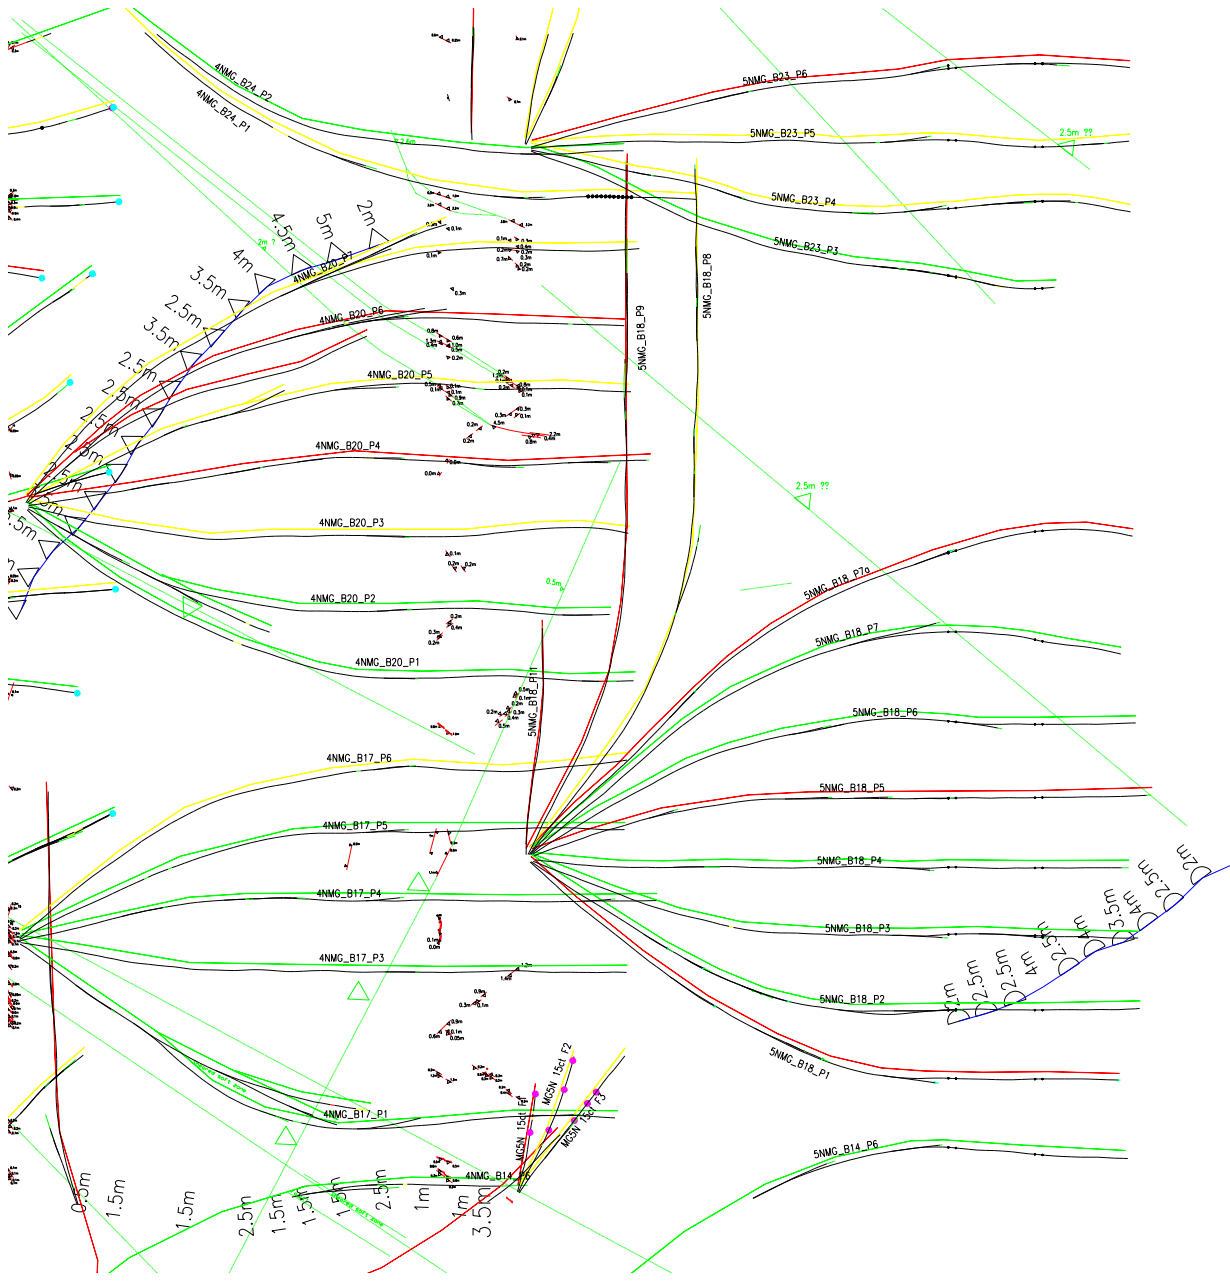
NORTH

The “as mined” geology, interpreted and predicted faulting, seismic deduced faulting and other black magic was overlain on the coloured hole flows.

A reasonable expectation would have been to have all the holes which cross a main fault to have similar flow characteristics.

But No; some are good, some exceptional and some just plain dogs. The same split occurs in unfaulted stub patterns (if there is such a thing at NG).

Larger scale faulting does not seem to provide the uniform control on hole gas flows and therefore permeability.
